[Docket No. FAA-2012-0415; Directorate Identifier 2008-SW-065-AD]

Airworthiness Directives; Bell Helicopter Textron, Incorporated Helicopters

ACTION: Notice of proposed rulemaking (NPRM).

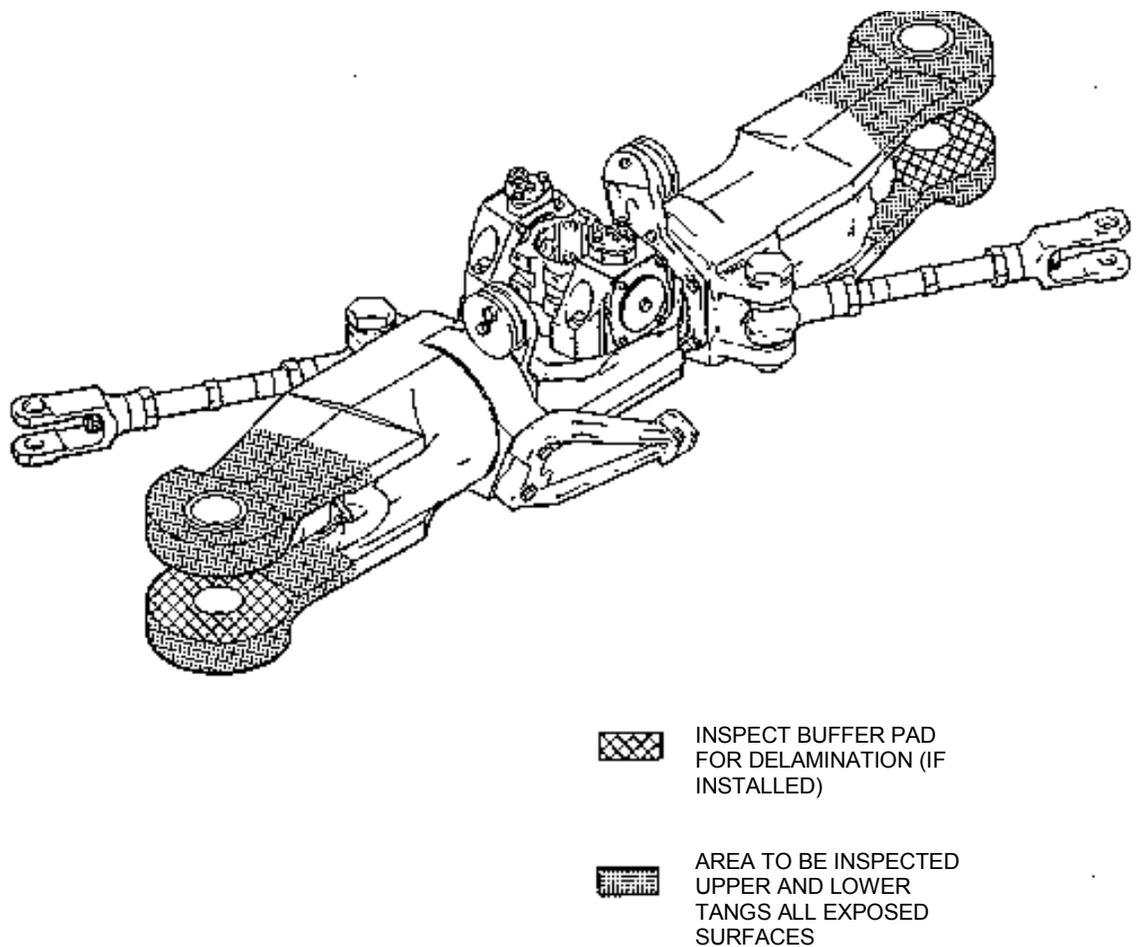
Figure 1. Inspection of Main Rotor Hub Grip Tangs

(ii) Using a 10-power or higher magnifying glass, visually inspect the exposed surfaces of the upper and lower tangs of each grip for a crack. Pay particular attention to the lower surface of each lower grip tang from the main rotor blade bolt-bushing flange to the leading and trailing edge of each grip tang. See Figure 1 of this AD.

- (i) Remove each main rotor blade, and
- (ii) Inspect each grip buffer pad on the inner surfaces of each grip tang for delamination (see Figure 1 of this AD). If there is any delamination, remove the buffer pad and inspect the grip surface for corrosion or other damage.

- (i) Replace any cracked grip with an airworthy grip.

(ii) Replace any grip with any corrosion or other damage with an airworthy grip, or repair the grip if the corrosion or other damage is within the maximum repair damage limitations found in the applicable Component and Repair Overhaul Manual.
