[Docket No. FAA-2012-0896; Directorate Identifier 2010-SW-070-AD; Amendment 39-17173; AD 2012-17-10]

Airworthiness Directives; Various Restricted Category Helicopters

2012-17-10 **VARIOUS RESTRICTED CATEGORY HELICOPTERS:** Amendment 39-17173; Docket No. FAA-2012-0896; Directorate Identifier 2010-SW-070-AD.

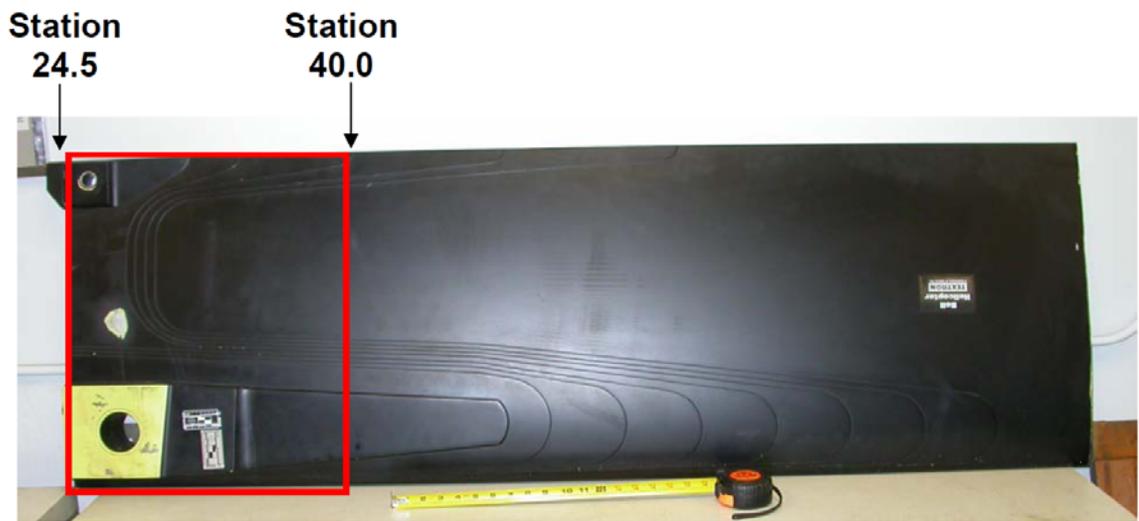
(ii) Using a 3x power or higher magnifying glass and a bright light, on each affected M/R blade, in an area from blade stations 24.5 to 40, including the entire width of the M/R blade chord, as depicted in Figure 1 to Paragraph (e) of this AD:

(A) Visually inspect the upper and lower grip plates and doublers of the M/R blade for an edge void, any corrosion, or a crack.

(B) Visually inspect the remaining upper and lower surfaces of the M/R blade for an edge void, any corrosion, or a crack.

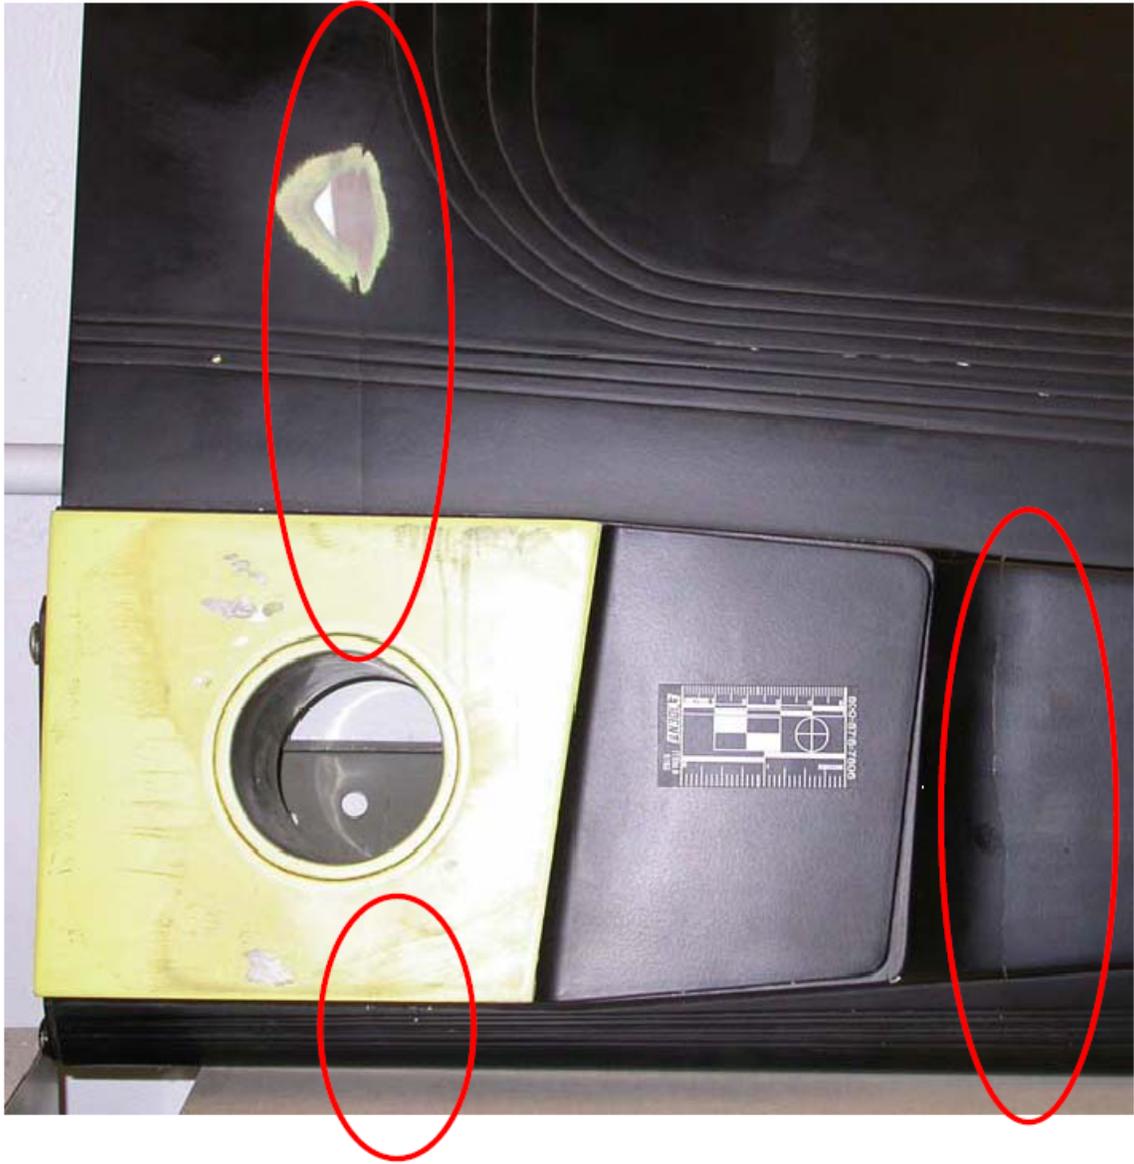
Note 2 to paragraph (e)(1)(ii): Crack indications on an actual M/R blade are shown in Figure 2 to Paragraph (e) of this AD.

(v) If there is a crack in any grip plate or doubler, replace the M/R blade with an airworthy M/R blade.

(vi) If there is a crack in the M/R blade skin, replace the M/R blade with an airworthy M/R blade, or repair the M/R blade if the damage is within the maximum repair damage limits.
