Amendment 39-17409; AD 2013-07-05]

Airworthiness Directives; Eurocopter France Helicopters

SUMMARY: We are adopting a new airworthiness directive (AD) for Eurocopter France EC130B4 helicopters. This AD requires visually checking the center windscreen panel (center windscreen) for a crack and replacing the center windscreen if there is a crack, if the windscreen distorts during flight, or within 12 months. This AD was prompted by in-flight cracking and failure of a center windscreen. The actions of this AD are intended to detect a crack in the blending radii of the center windscreen to prevent failure of the windscreen, injury to the flight crew, and subsequent loss of control of the helicopter.

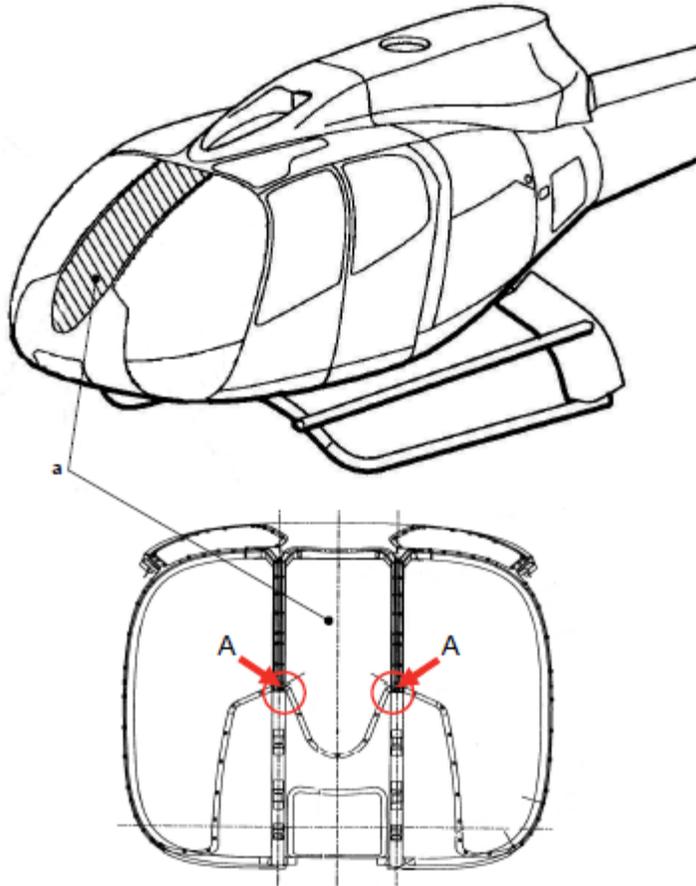
Figure 1 to Paragraph (e)(1)

This AD defines the unsafe condition as a crack in the blending radii of the center windscreen, which could lead to failure of the center windscreen, injury to the flight crew, and subsequent loss of control of the helicopter.

(1) Until the center windscreen is replaced with center windscreen P/N 350A25-9045-20, before each flight, visually check the center windscreen for a crack in the area of the blending radii where the front-lower part of the center windscreen joins the front fuselage as depicted in Figure 1 to paragraph (e)(1) of this AD. This visual check may be performed by the owner/operator (pilot) holding at least a private pilot certificate, and must be entered into the aircraft records showing compliance with this AD in accordance with Title 14 Code of Federal Regulations (14 CFR) 43.9 (a)(1)-(4)

(2) If there is a crack or if a pilot indicates that the center windshield distorted during flight, before further flight, replace the center windshield with an airworthy center windshield, P/N 350A25-9045-20, in accordance with the Accomplishment Instructions, paragraphs 2.B.2.b. through 2.B.2.b.4., of Eurocopter Service Bulletin No. 56-003, Revision 0, dated November 16, 2010.

(3) Within 12 months, replace the center windshield with an airworthy center windshield, P/N 350A25-9045-20, in accordance with the instructions contained in paragraph (e)(2) of this AD.
