[Docket No. FAA-2014-0337; Directorate Identifier 2013-SW-029-AD]

Airworthiness Directives; Various Restricted Category Helicopters

ACTION: Notice of proposed rulemaking (NPRM).

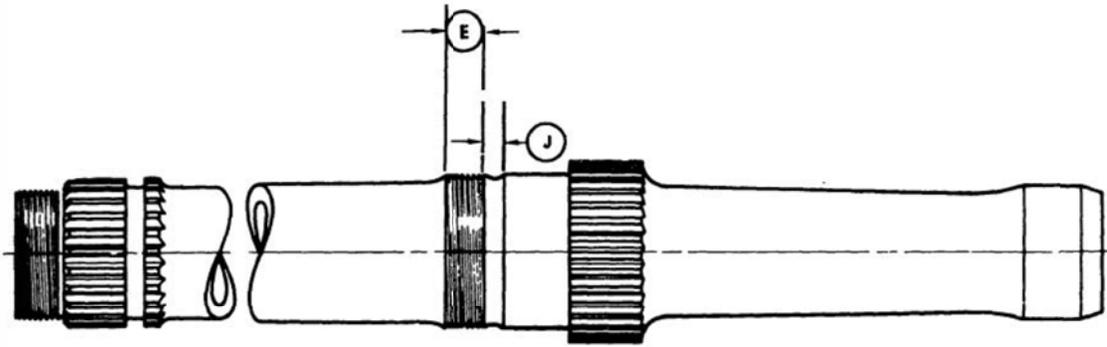
This AD defines the unsafe condition as a crack in the main rotor mast, which could result in failure of the mast and subsequent loss of control of the helicopter.

(i) Remove any surface rust with a wire brush or steel wool and, using a 10X or higher power magnifying glass, inspect the areas of the mast as shown in area E and area J of Figure 1 to Paragraph (f) of this AD for pitting, corrosion, or a crack.

(2) If there is a crack, pitting, or corrosion, before further flight, replace the mast with an airworthy mast.
