[Docket No. FAA-2016-6651; Directorate Identifier 2016-SW-015-AD; Amendment 39-18867; AD 2017-09-05]

Airworthiness Directives; Airbus Helicopters

2017-09-05 **Airbus Helicopters:** Amendment 39-18867; Docket No. FAA-2016-6651; Directorate Identifier 2016-SW-015-AD.

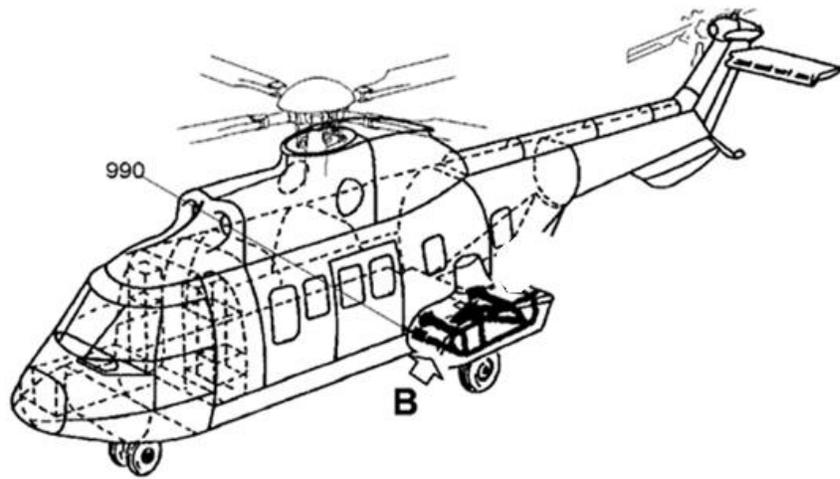
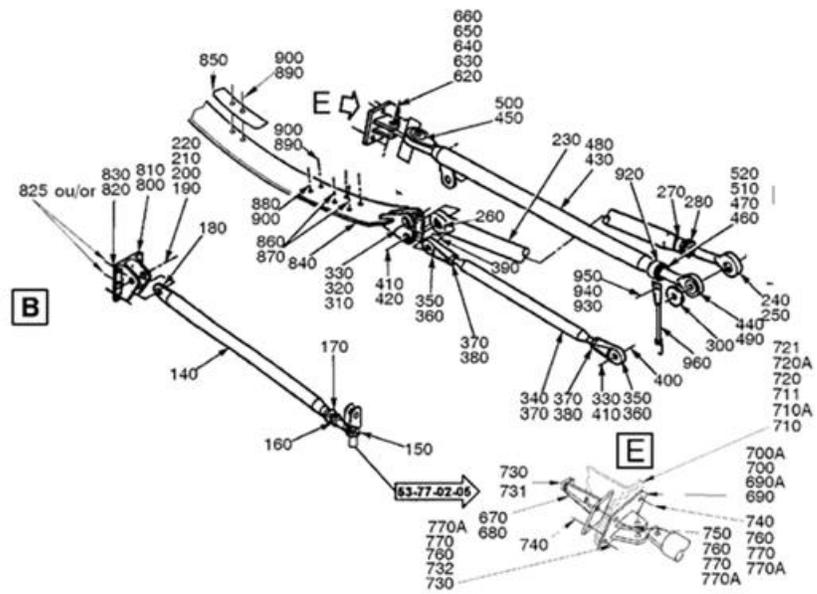
Figure 1 to Paragraph (e)(1) of this AD

EASA advises that a screw ruptured on the rear upper fitting on the left-hand (LH) emergency flotation gear of an AS332 helicopter. EASA states that this condition, if not detected and corrected, could result in the failure of an emergency flotation system when ditching and unstable floating of the helicopter, possibly resulting in injury to the occupants. EASA consequently requires repetitive inspections of the lower attachment screws of rear upper fitting on the rear LH and right-hand (RH) emergency flotation gears. According to EASA, the root cause of the failure has not yet been identified.

This AD defines the unsafe condition as failure of a rear upper screw fitting on

the emergency flotation gear. This condition, if not detected and corrected, could result in failure of the emergency flotation system and subsequent capsizing of the helicopter.

(1) Visually check each emergency flotation gear left hand and right hand rear upper fitting to determine whether the heads of the lower screws are present. Figure 1 to paragraph (e)(1) of this AD depicts where the lower three screws (noted as B and E) are located. Check each screw for looseness by determining whether it can be rotated by hand. The actions required by paragraph (e)(1) of this AD may be performed by the owner/operator (pilot) holding at least a private pilot certificate and must be entered into the aircraft records showing compliance with this AD in accordance with Title 14 Code of Federal Regulations (14CFR) §§ 43.9(a)(1)-(4) and 14 CFR 91.417(a)(2)(v). The record must be maintained as required by 14 CFR §§ 91.417, 121.380, or 135.439.

(2) If a screw head is missing or if a screw is loose, before further flight over water, replace all screws in the fitting. Replacing the screws is not a terminating action for the repetitive checks required by this AD.
