**[Docket No. FAA-2017-0288; Product Identifier 2017-CE-007-AD]**

**Airworthiness Directives; Textron Aviation Inc. Airplanes**

**ACTION:** Supplemental notice of proposed rulemaking (SNPRM); reopening of comment period.

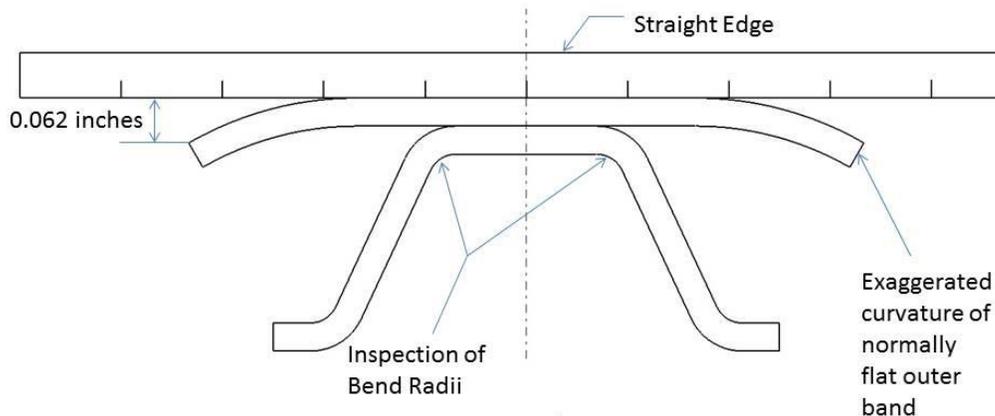
Figure 1 to paragraphs (k)(1)(iii) and (v) of this AD: Cross section of v-band coupling

(iii) Visually inspect the flatness of the outer band using a straight edge. Lay the straight edge across the width of the outer band. The gap must be less than 0.062 inches. See figure 1 to paragraphs (k)(1)(iii) and (v) of this AD. If the gap exceeds 0.062 inches between the outer band and the straight edge, do not re-install the v-band coupling. Before further flight, you must install a new v-band coupling and restart the hours TIS for the repetitive replacement of the v-band coupling.

(v) Visually inspect the bend radii of the coupling v-retainer coupling segments for cracks. Inspect the radii throughout the length of the segment. See figure 1 to paragraphs (k)(1)(iii) and (v) of this AD. If any cracks are found, do not re-install the

v-band coupling. Before further flight, you must install a new v-band coupling and restart the hours TIS for the repetitive replacement of the v-band coupling.
