[Docket No. FAA-2018-1046; Product Identifier 2018-CE-049-AD]

Airworthiness Directives; Piper Aircraft, Inc. Airplanes

ACTION: Notice of proposed rulemaking (NPRM).

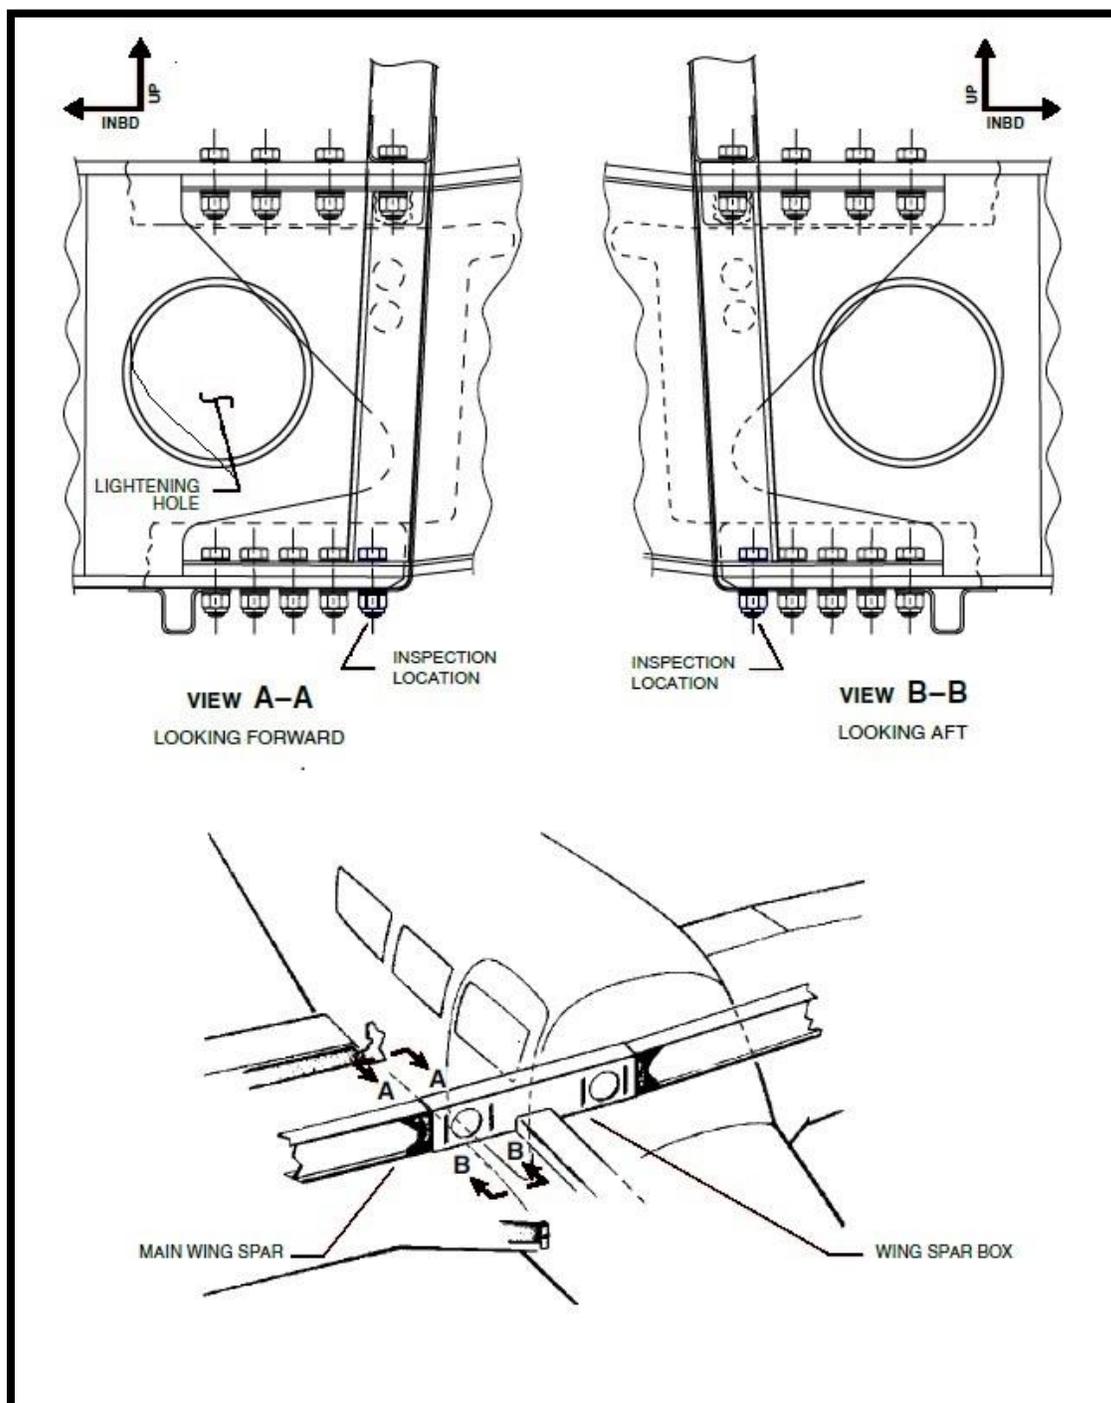
Figure 1. Main Spar Attach Bolt Locations (RH Side Shown)

This AD was prompted by a report of a fatigue crack found in a visually inaccessible area of the lower main wing spar cap. We are issuing this AD to detect and correct fatigue cracks in the lower main wing spar cap bolt holes. The unsafe condition, if not addressed, could result in the wing separating from the fuselage in flight.

(1) Locate the two (2) lower outboard main spar attach bolts, as shown in Figure 1 of Appendix 1, installed on the lower cap of the main spar, on the forward and aft sides of the spar web.

If a crack is found during an inspection required in paragraph (h) of this AD, before further flight, replace the main wing spar with a new (zero hours TIS) main wing spar or with a main wing spar that has been inspected as specified in appendix 1 of this AD and no cracks were found.

(3) Use eddy current surface and bolt hole examinations to detect surface and shallow subsurface cracking and discontinuities on the left and right lower outboard spar bolt holes. Use SAE ARP4402, "Eddy Current Inspection of Open Fastener Holes in Aluminum Aircraft Structure," or another FAA-approved eddy current inspection method to do these inspections.

A crack or crack-like indication with an amplitude equal to or greater than 50 percent of the reference level signal must be rejected and documented. Such an amplitude reading indicates that the spar does not meet type design.
