DEPARTMENT OF TRANSPORTATION

National Highway Traffic Safety Administration

[Docket No. NHTSA-2018-0020]

Denial of Motor Vehicle Defect Petition, DP13-001

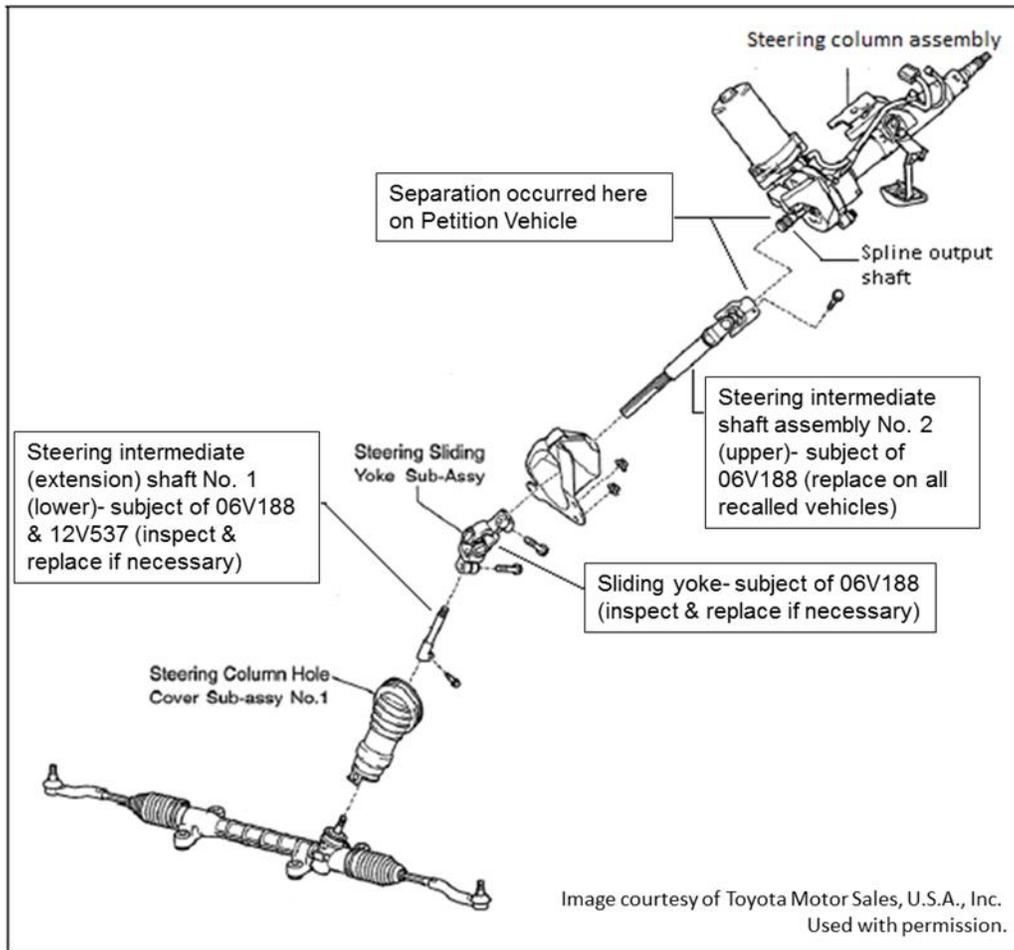
The subject power steering system is assisted by an electric motor linked to the steering column assembly. Steering torque is transmitted to a manual steering rack via a pair of intermediate shafts and a sliding yoke assembly. Image 1 below illustrates the Toyota Prius steering system and the components subjected to the two recalls.
