[Docket No. FAA-2018-0893; Product Identifier 2018-SW-032-AD; Amendment 39-21319; AD 2020-23-03]

Airworthiness Directives; Airbus Helicopters

2020-23-03 Airbus Helicopters: Amendment 39-21319; Docket No. FAA-2018-0893; Product Identifier 2018-SW-032-AD.

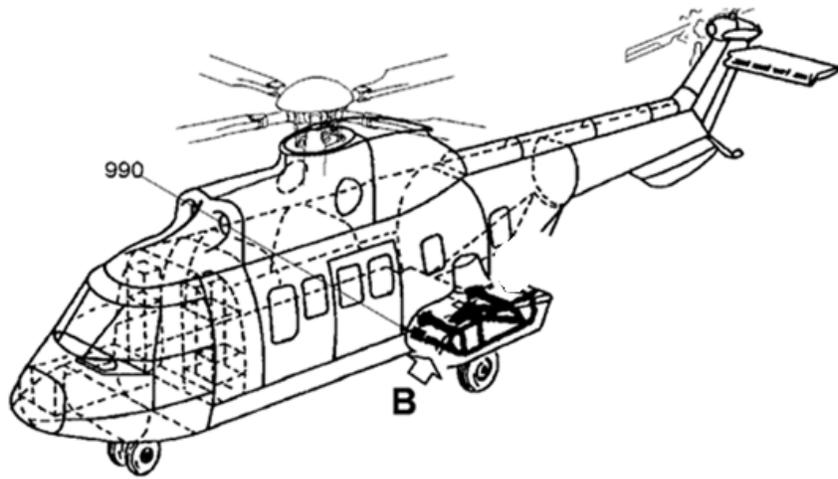
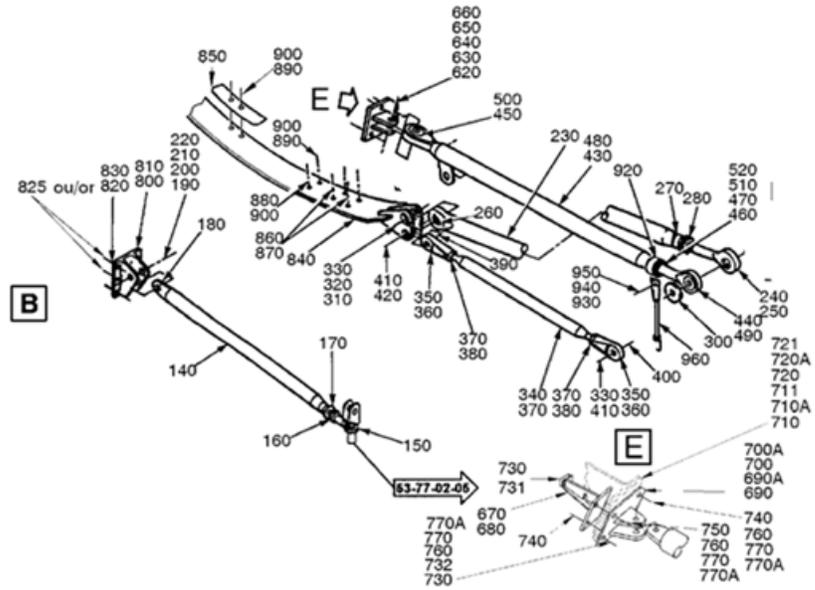
Figure 1 to Paragraph (f)(1)

After the FAA issued AD 2017-09-05, Airbus Helicopters identified the root cause of the screw rupture as a tapering gap under the fitting attachment screw heads

creating excessive stress loads. Consequently, EASA issued AD No. 2018-0090, dated April 20, 2018 (EASA AD 2018-0090), to supersede EASA AD 2015-0239-E. EASA AD 2018-0090 retains the repetitive inspection requirements in EASA AD 2015-0239-E and also requires the installation of Airbus Helicopters MOD 0728456 as a terminating action for the repetitive inspections. MOD 0728456 involves the installation of spherical washers and longer screws on the rear upper fittings of the flotation gear to remove the stress applied to the screw heads.

This AD defines the unsafe condition as failure of a rear upper screw fitting on the emergency flotation gear. This condition, if not detected and corrected, could result in failure of the emergency flotation system and subsequent capsizing of the helicopter.

(1) Within 15 hours time-in-service (TIS), and before each flight over water thereafter, visually check each emergency flotation gear left hand (LH) and right hand (RH) rear upper fitting to determine whether the heads of the lower screws are present. Figure 1 to paragraph (f)(1) of this AD depicts where the lower three screws (noted as B and E) are located. Check each screw for looseness by determining whether it can be rotated by hand. These actions may be performed by the owner/operator (pilot) holding at least a private pilot certificate and must be entered into the aircraft records showing compliance with this AD in accordance with 14 CFR 43.9(a)(1) through (4) and 14 CFR 91.417(a)(2)(v). The record must be maintained as required by 14 CFR 91.417, 121.380, or 135.439.

(2) If a screw head is missing, or if a screw is loose, before further flight over water, install MOD 0728456 by completing paragraph (f)(3) of this AD.

(3) Within 300 hours TIS, unless required before further flight over water by paragraph (f)(2) of this AD, install MOD 0728456 by doing the following:
