[Docket No. FAA-2020-0442; Project Identifier AD-2020-00260-E; Amendment 39-21640; AD 2021-14-13]

Airworthiness Directives; Pratt & Whitney Turbofan Engines

ACTION: Final rule.

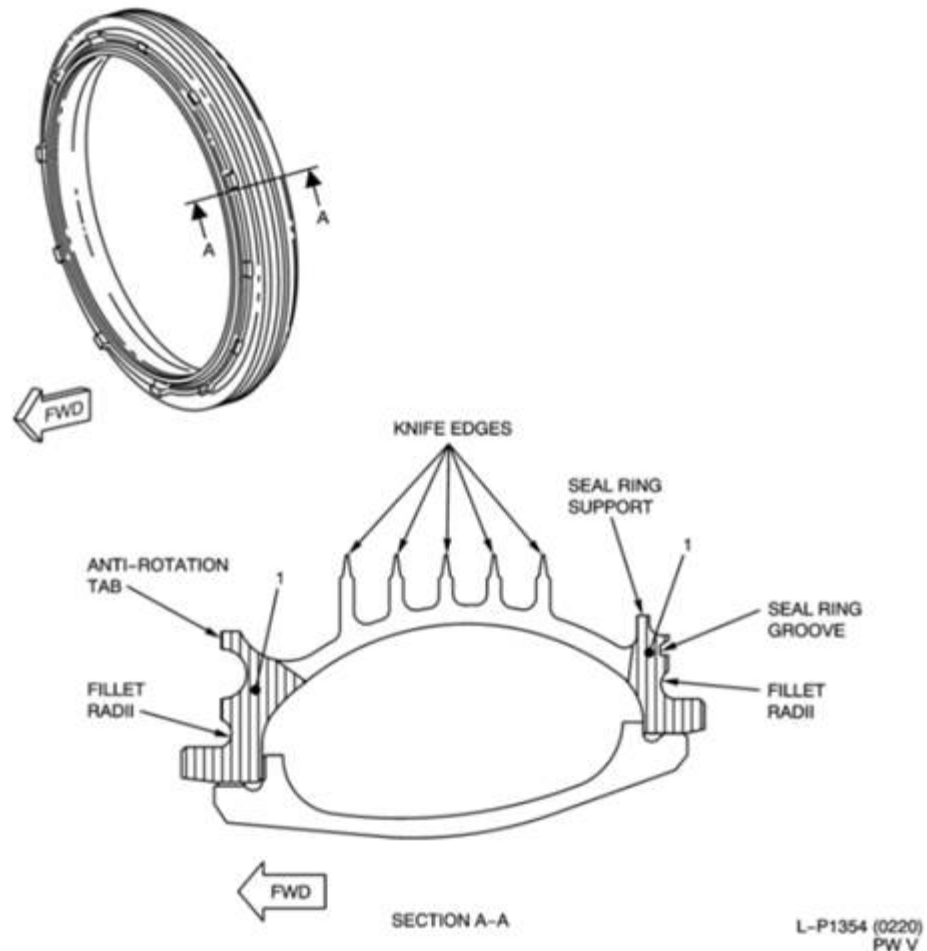
Figure 1 to Paragraph (g)(1)(iii) – Crack Inspection Critical Areas

The FAA did not revise this AD in response to this comment. A crack, as identified in the shaded regions of Figure 1 to paragraph (g)(1)(iii) of this AD (Figure 1), which extends towards the knife-edge region of the HPT 2nd-stage air seal assembly, impacts the serviceability of the mating HPT 1st-stage disk and the HPT 2nd-stage hub. A crack identified in the shaded region of Figure 1 of this AD of the HPT 2nd-stage air seal assembly results in the requirement to remove the HPT 2nd-stage air seal assembly, mating HPT 1st-stage disk, and HPT 2nd-stage hub.

If a crack is found as identified in the shaded region of Figure 1 to paragraph (g)(1)(iii) of this AD (Figure 1) that extends toward the knife-edge region of the HPT 2nd-stage air seal assembly, this AD requires replacement of the HPT 2nd-stage air seal assembly, mating HPT 1st-stage disk, and HPT 2nd-stage hub.

The FAA agrees that it is difficult to differentiate between a surface crack and through-crack; therefore, the FAA removed references to “through-crack” from this AD. The FAA notes that any crack, in any direction, found in the HPT 2nd-stage air seal assembly, requires removal of the HPT 2nd-stage air seal assembly from service. As stated in an earlier response, the FAA added Figure 1 to show the locations of the HPT 2nd-stage air seal assembly that require inspection for cracks. However, the FAA is not providing dimensions that bind the areas. If the inspections of the HPT 2nd-stage air seal assembly reveal a crack in the shaded regions of Figure 1, which extends towards the knife-edge region, the HPT 2nd-stage air seal assembly must be removed from service.

This AD was prompted by a report of an uncontained engine failure resulting from cracks originating in the knife edge of the high-pressure turbine (HPT) 2nd-stage air seal assembly. The FAA is issuing this AD to prevent failure of the HPT 2nd-stage air seal assembly. The unsafe condition, if not addressed, could result in uncontained HPT 2nd-stage air seal assembly release, damage to the engine, and damage to the airplane.

(iii) During the visual inspection or FPI required by paragraph (g)(1)(i) of this AD, if a crack is found in the shaded regions of the HPT 2nd-stage air seal assembly identified in Figure 1 to paragraph (g)(1)(iii) of this AD (Figure 1), which extends towards the knife-edge region of the HPT 2nd-stage air seal assembly, remove the HPT 2nd-stage air seal assembly, mating HPT 1st-stage disk, and HPT 2nd-stage hub from service, and replace the parts with parts eligible for installation. In order to return the

mating HPT 1st-stage disk and HPT 2nd-stage hub to service, the inspections of the HPT 2nd-stage air seal assembly cannot reveal a crack identified in the shaded regions of Figure 1, which extends towards the knife-edge region.

(ii) If a crack is found in the HPT 2nd-stage air seal assembly during the visual inspection or FPI required by paragraph (g)(1)(i) of this AD, remove the HPT 2nd-stage air seal assembly from service and replace it with a part eligible for installation.
