[Docket No. FAA-2023-1814; Project Identifier AD-2023-00773-T; Amendment 39-22541; AD 2023-17-14]

Airworthiness Directives; The Boeing Company Airplanes

2023-17-14 The Boeing Company: Amendment 39-22541; Docket No. FAA-2023-1814; Project Identifier AD-2023-00773-T.

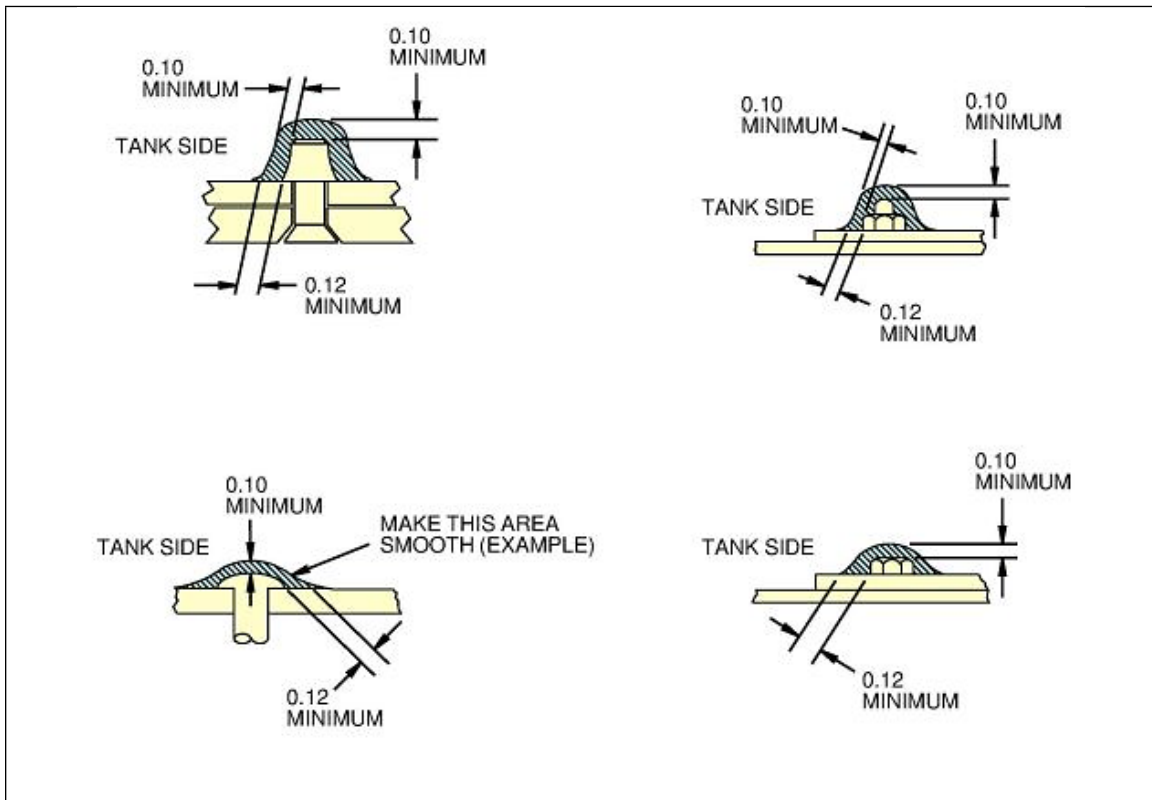
Figure 1 to paragraph (h)(4) – Cap seal minimum thickness (all dimensions in inches)

(4) During application of any cap seal to a fastener, fastener head, and fastener threads and collars, as required by this AD, the cap seal must be applied with a thickness equal to or greater than the dimensions specified in figure 1 to paragraph (h)(4) of this AD.

this AD requires that if the cap seal is removed, a cap seal of BMS 5-45 sealant be reapplied with a thickness equal to or greater than the dimensions specified in figure 1 to paragraph (h)(4) of this AD before further flight after completion of the inspection.

(2) If any cap seal was applied using procedures with thickness dimensions less than those given in figure 1 to paragraph (h)(4) of this AD, or if the maintenance records do not definitively specify the procedures used: At the applicable time specified in paragraph (i)(2)(i) or (ii) of this AD, replace the cap seal in accordance with the Accomplishment Instructions of Boeing Alert Requirements Bulletin 777-57A0122 RB, dated October 8, 2021, using a cap sealing procedure with thickness greater than or equal to the dimensions given in figure 1 to paragraph (h)(4) of this AD.

(3) For any cap seal that was not applied, or for any cap seal that was removed for inspections and not replaced, or if the maintenance records do not definitively specify the procedures used: At the applicable time specified in paragraph (i)(3)(i) or (ii) of this AD, apply a cap seal of BMS 5-45 sealant using an accepted method with thickness greater than or equal to the dimensions given in figure 1 to paragraph (h)(4) of this AD.
