[Docket No. FAA-2023-1993; Project Identifier AD-2023-00129-T]

Airworthiness Directives; The Boeing Company Airplanes

ACTION: Notice of proposed rulemaking (NPRM).

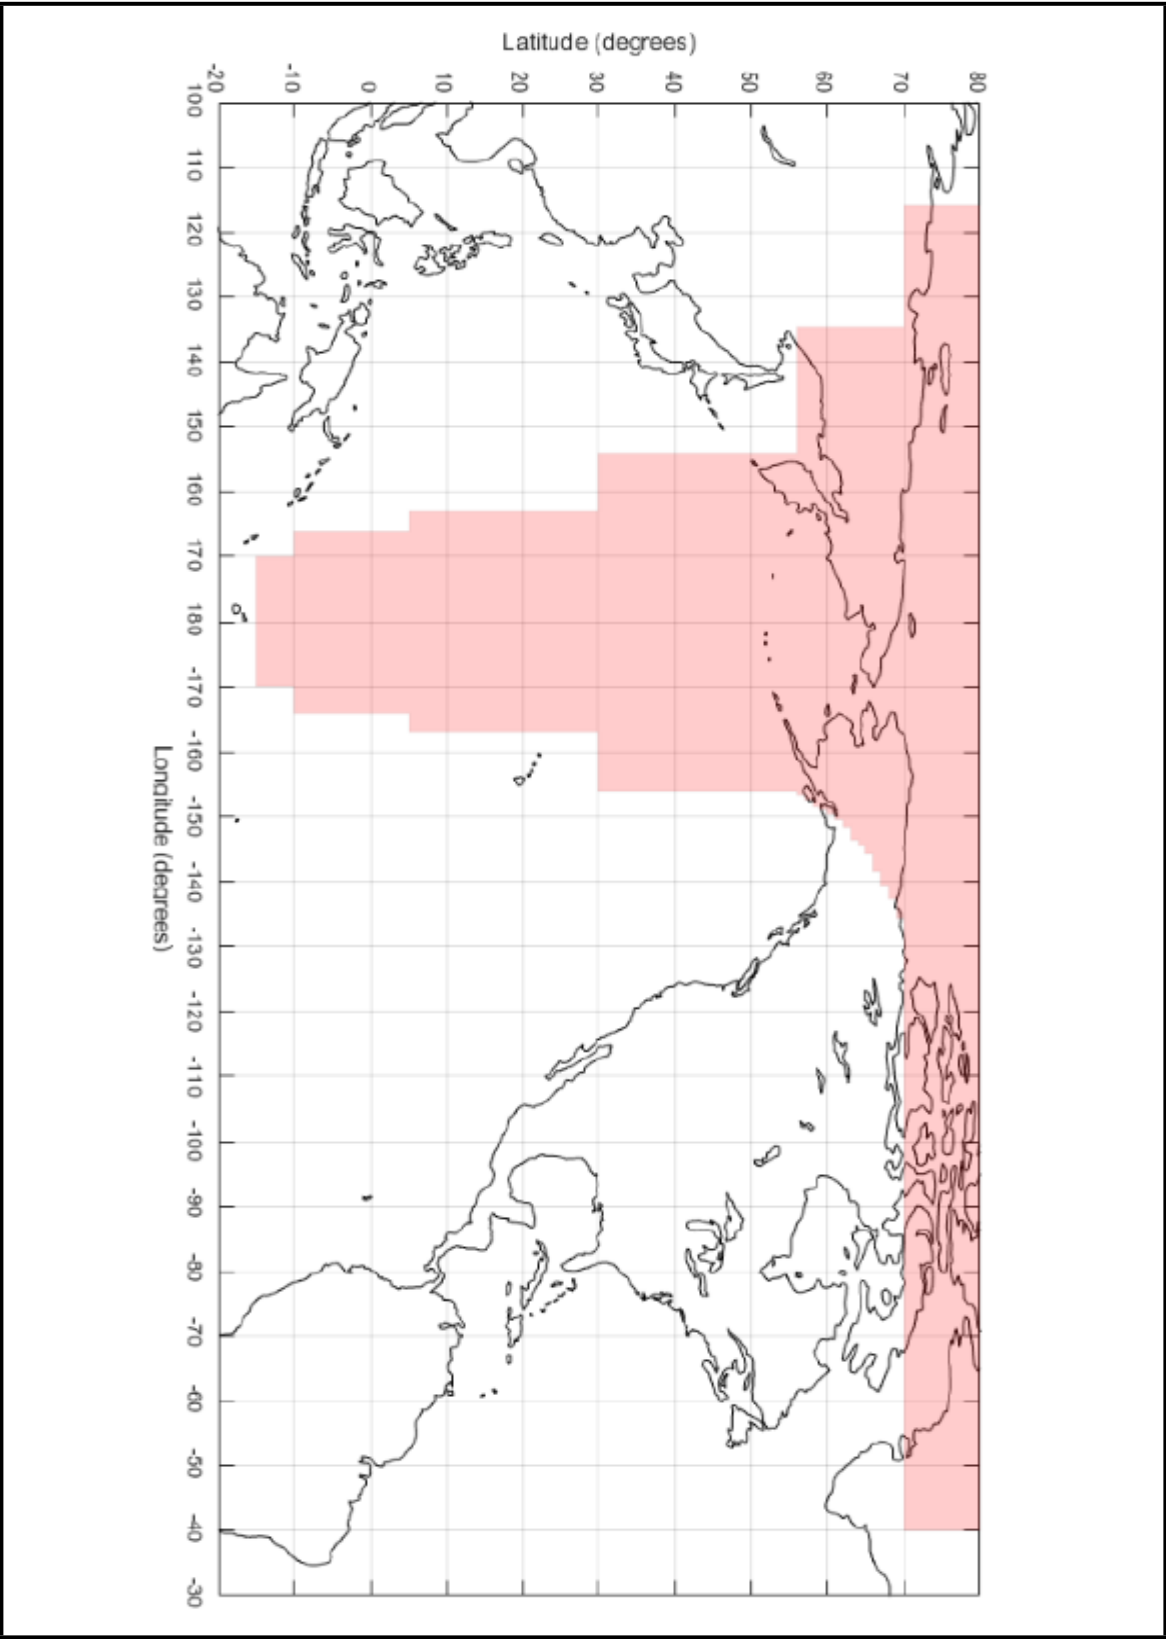
Figure 2 to paragraph (g) – AFM – Limitations or Certificate Limitations continued

Operations that require less than 0.3 RNP (For example, 0.1, 0.11, 0.15, etc.) in the region identified below are prohibited with GLU-2100 OPS software number COL4D-0087-0002, COL4E-0087-0001, COL48-0087-0700, or COL49-0087-0701 installed.

Region bounded by the following coordinates:
