## DEPARTMENT OF TRANSPORTATION

[Docket No. FAA-2023-2232; Project Identifier AD-2023-00943-R]

#### Airworthiness Directives; Robinson Helicopter Company Helicopters

**ACTION:** Notice of proposed rulemaking (NPRM).

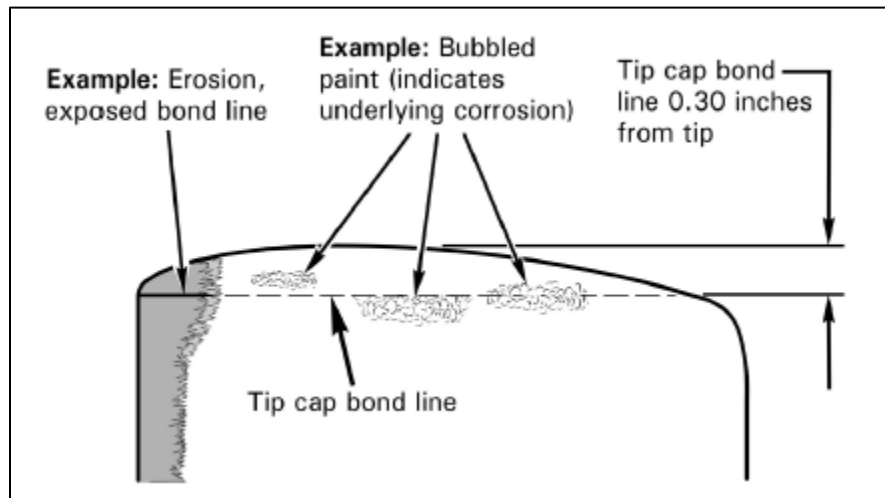
### Figure 1 to Paragraph (g)(1) - TRB Tip Cap Check/Inspection

(1) Within 10 hours time-in-service (TIS) after the effective date of this AD and thereafter before the first flight of each day, visually check each TRB tip cap area (at and adjacent to the tip cap bond line on each surface and edge of the TRB) for an exposed tip cap bond line or bubbled paint, as depicted in Figure 1 of paragraph (g)(1) of this AD. These items may indicate evidence of corrosion. The owner/operator (pilot) holding at least a private pilot certificate may accomplish this TRB tip cap check and must enter compliance with this paragraph of the AD into the helicopter maintenance records in accordance with 14 CFR 43.9(a) and 91.417(a)(2)(v). The record must be maintained as required by 14 CFR 91.417, 121.380, or 135.439.

(2) Within 100 hours TIS or during the next 100 hour or annual inspection after the effective date of this AD, whichever occurs first, and thereafter at intervals not to exceed 100 hours TIS or during the next 100 hour or annual inspection, whichever occurs first, visually inspect each TRB tip cap area (at and adjacent to the tip cap bond line on each surface and edge of the TRB) for evidence of corrosion, which may be indicated by an exposed tip cap bond line or bubbled paint, as depicted in Figure 1 of paragraph (g)(1) of this AD.

(3) As a result of the actions required by either paragraph (g)(1) or (2) of this AD, if there is evidence of corrosion, an exposed tip cap bond line, or bubbled paint, before further flight, remove all of the corrosion.
