[Docket No. FAA-2023-2232; Project Identifier AD-2023-00943-R; Amendment 39-22681; AD 2024-04-02]

Airworthiness Directives; Robinson Helicopter Company Helicopters

ACTION: Final rule.

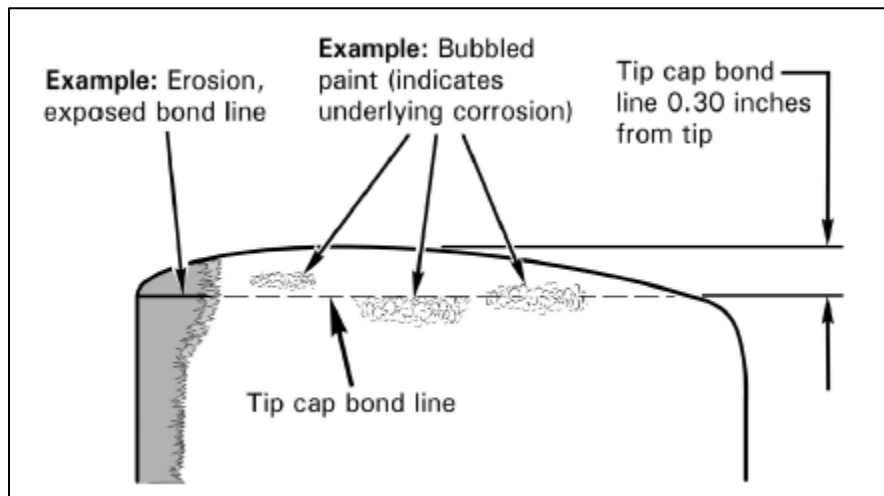
Figure 1 to Paragraph (g)(1) - TRB Tip Cap Check/Inspection

A debonded TRB tip cap can cause severe vibration and possible failure of the tail rotor gearbox housing. This condition, if not addressed, could result in increased vibrations, reduced controllability, and subsequent loss of control of the helicopter. The FAA is issuing this AD to address the unsafe condition on these products.

(1) Within 10 hours time-in-service (TIS) after the effective date of this AD and thereafter before the first flight of each day, visually check each TRB tip cap area (at and adjacent to the tip cap bond line on each surface and edge of the TRB) for an exposed tip cap bond line or bubbled paint, as depicted in Figure 1 to paragraph (g)(1) of this AD. These items may indicate evidence of corrosion. The owner/operator (pilot) holding at least a private pilot certificate may accomplish this TRB tip cap check and must enter compliance with this paragraph of the AD into the helicopter maintenance records in accordance with 14 CFR 43.9(a) and 91.417(a)(2)(v). The record must be maintained as required by 14 CFR 91.417, 121.380, or 135.439.

(2) Within 100 hours TIS or during the next 100 hour or annual inspection after the effective date of this AD, whichever occurs first, and thereafter at intervals not to exceed 100 hours TIS or during the next 100 hour or annual inspection, whichever occurs first, visually inspect each TRB tip cap area (at and adjacent to the tip cap bond line on each surface and edge of the TRB) for evidence of corrosion, which may be indicated by an exposed tip cap bond line or bubbled paint, as depicted in Figure 1 to paragraph (g)(1) of this AD.

(3) As a result of the actions required by either paragraph (g)(1) or (2) of this AD, if there is evidence of corrosion, an exposed tip cap bond line, or bubbled paint, before further flight, remove all of the corrosion.

(4) Within 10 months of the effective date of this AD, remove all TRBs identified in paragraph (c) of this AD from service.
