[Docket No. FAA-2025-0011; Project Identifier AD-2024-00618-R]

Airworthiness Directives; Robinson Helicopter Company Helicopters

ACTION: Notice of proposed rulemaking (NPRM).

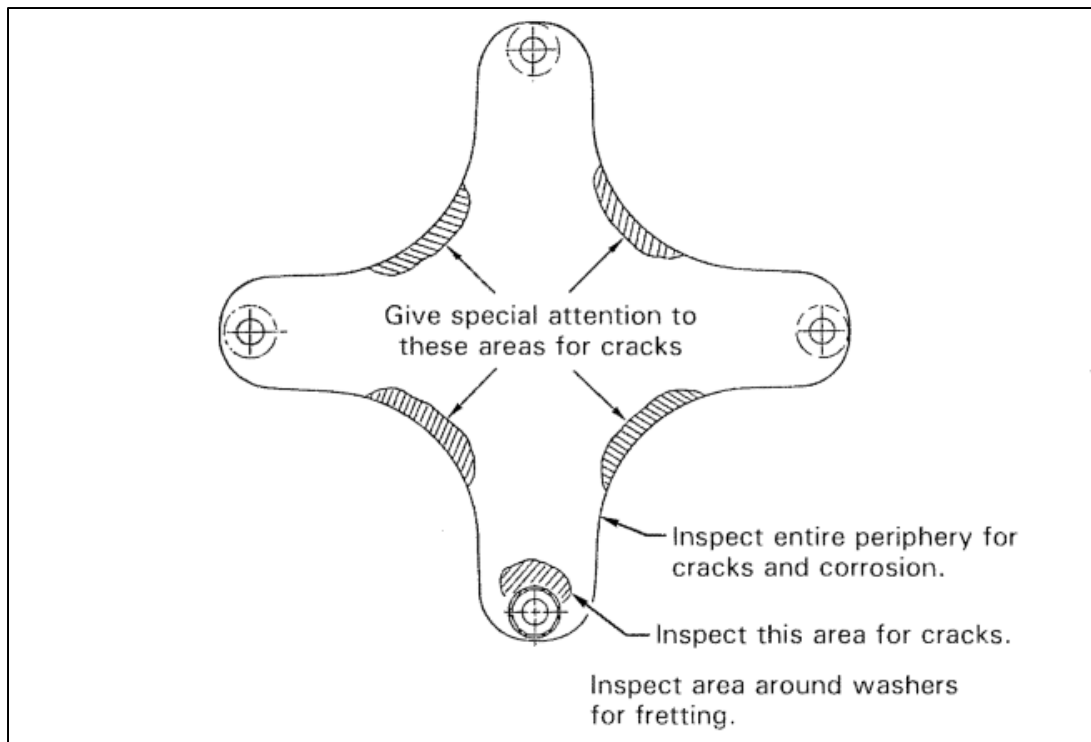
Figure 1 to Paragraph (g)(1)(i) - Flex Plate Inspection

(i) Visually inspect forward flex plate assembly part number (P/N) C947-1 (flex plate) for any loose fasteners, cracks, fretting, corrosion, wear, and to ensure that the washers are bonded to both sides of each flex plate arm, in the areas depicted in Figure 1 to paragraph (g)(1)(i) of this AD. If there is any loose fastener (can be moved by hand), crack, fretting, corrosion, or wear that consists of the washers not securely bonded to both sides of each flex plate arm, before further flight, remove the flex plate from service and replace it with an airworthy flex plate.
