[Docket No. FAA-2023-1993; Project Identifier AD-2023-00129-T; Amendment 39-22940; AD 2025-02-07]

Airworthiness Directives; The Boeing Company Airplanes

ACTION: Final rule.

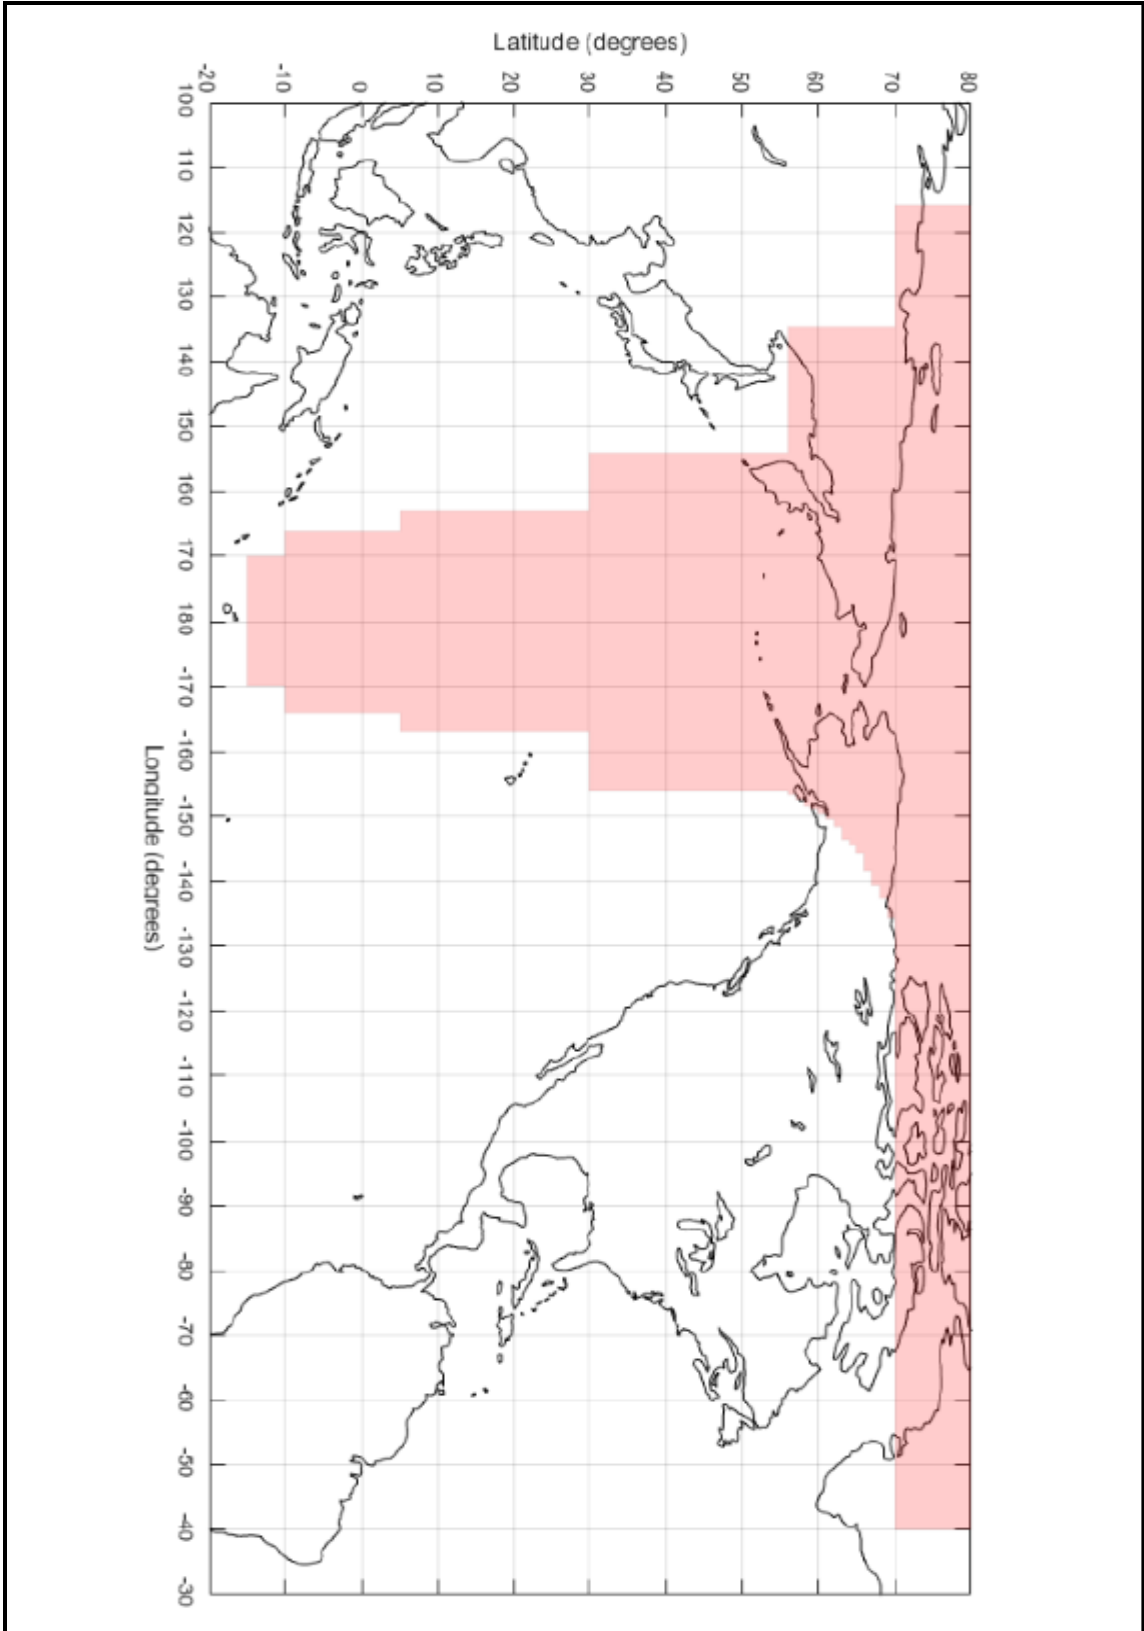
Figure 2 to paragraph (g) – AFM – Limitations or Certificate Limitations continued

Operations that require less than 0.3 RNP (For example, 0.1, 0.11, 0.15, etc.) in the region identified below are prohibited with GLU-2100 OPS software number COL4D-0087-0002, COL4E-0087-0001, COL48-0087-0700, or COL49-0087-0701 installed.

Exception: Anchorage (PANC) approach procedures that allow less than RNP 0.3 are authorized provided the instructions outlined in the Electronics – Global Landing Unit Section of Normal Procedures Chapter are followed.

Note: Currently, Fairbanks (PAFA) and Anchorage (PANC) are the only airports in the region with an RNP approach that requires better than 0.3 nmi performance.
