**[Docket No. FAA-2024-1896; Project Identifier MCAI-2023-00978-T; Amendment
39-22966; AD 2025-04-08]**

**Airworthiness Directives; MHI RJ Aviation ULC (Type Certificate Previously Held
by Bombardier Inc.) Airplanes**

ACTION: Final rule.

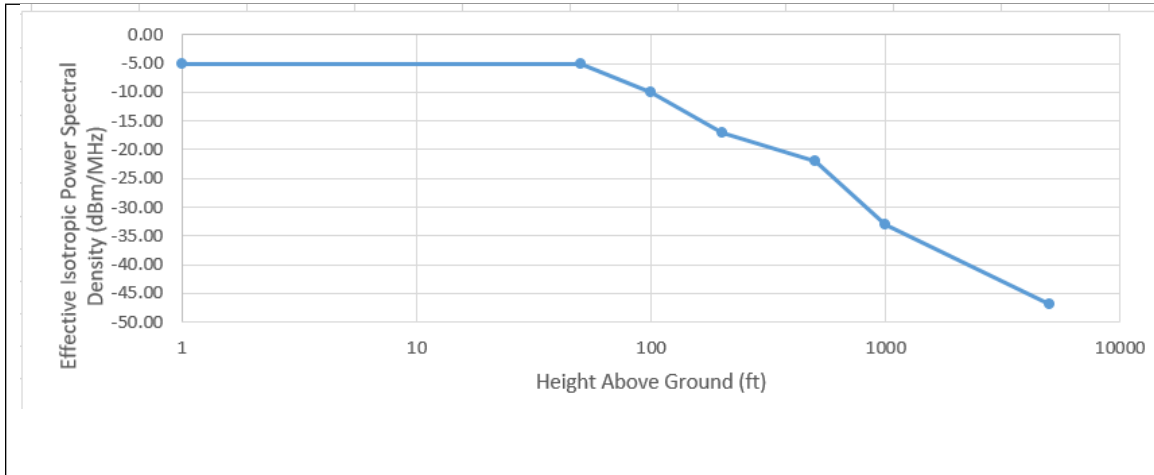
Figure 1 to paragraph (g)(1) – Fundamental Effective Isotropic PSD at Outside Interface of Airplane Antenna

(1) Tolerance to radio altimeter interference, for the fundamental emissions (3.7-3.98 GHz), at or above the power spectral density (PSD) curve threshold specified in figure 1 to paragraph (g)(1) of this AD.

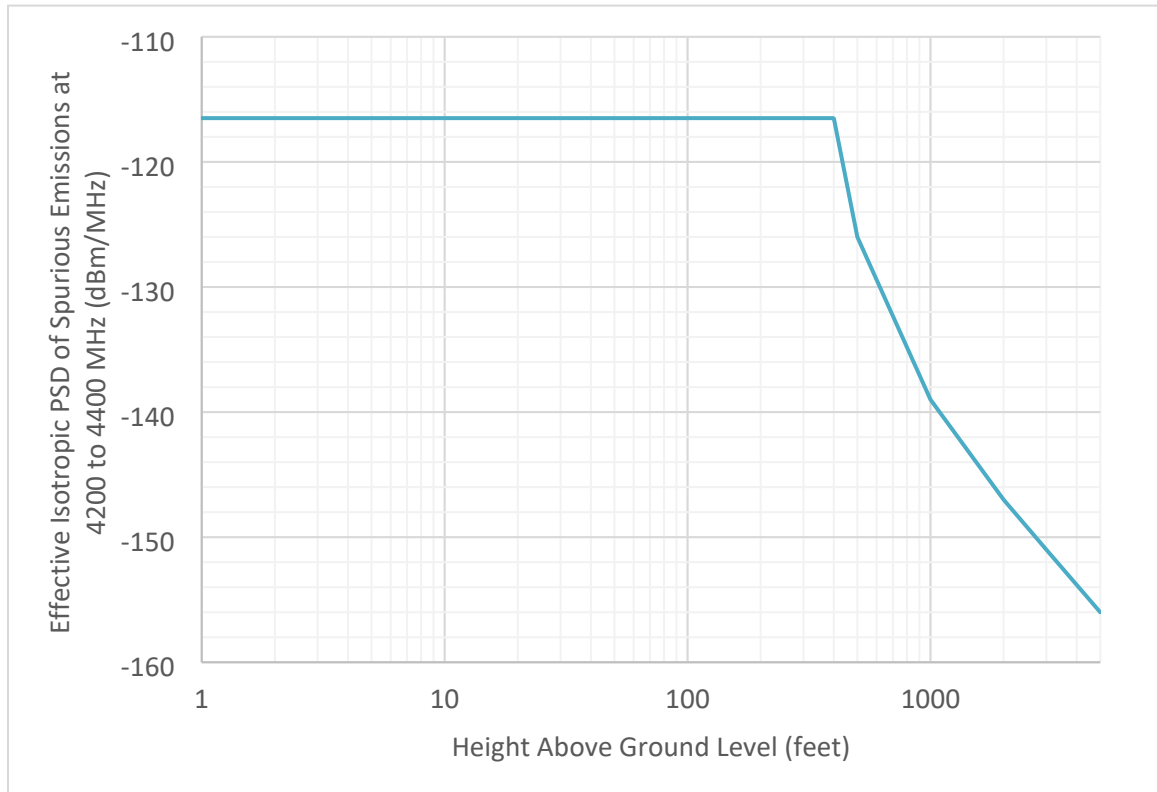
Figure 2 to paragraph (g)(2) – Spurious Effective Isotropic PSD at Outside Interface of Airplane Antenna

(2) Tolerance to radio altimeter interference, for the spurious emissions (4.2-4.4 GHz), at or above the PSD curve threshold specified in figure 2 to paragraph (g)(2) of this AD.
