[Docket No. FAA-2025-0922; Project Identifier MCAI-2024-00650-R]

Airworthiness Directives; Airbus Helicopters

ACTION: Notice of proposed rulemaking (NPRM).

This AD applies to Airbus Helicopters Model EC120B helicopters, certificated in any category.

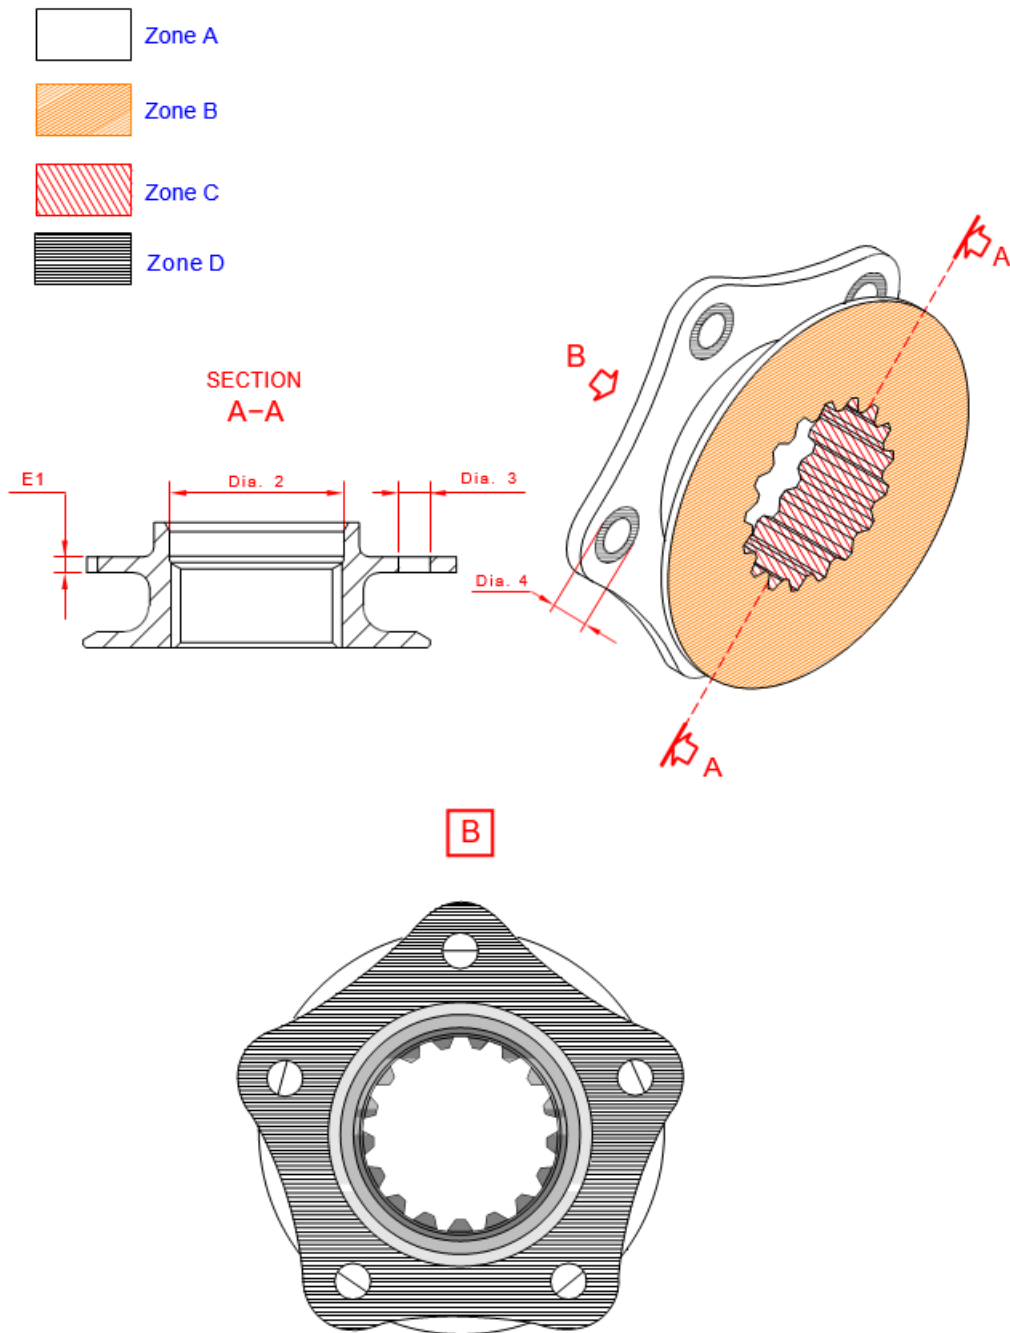
Figure 2 to paragraph (g)(1)(ii) – Inspection Areas of Tail Rotor Splined Flange

(ii) Inspect the TR splined flange for corrosion, impacts, fretting, wear, and a crack in the areas identified in Figure 2 to paragraph (g)(1)(ii) of this AD. If the condition of the part (including corrosion, impacts, fretting, wear, or cracks) exceeds the criteria as specified in Figure 1 to paragraph (g)(1)(ii) of this AD, before further flight, remove the splined flange from service and replace with an airworthy part.

Location as specified in Figure 2 to paragraph (g)(1)(ii) of this AD	Maximum damage, which causes replacement (E1, Dia. 2, Dia. 3, and Dia. 4 are shown in Figure 2 to paragraph (g)(1)(ii) of this AD)
Zone A	Scratch depth > 0.2 mm (0.008 in.). Crack. E1 < 2.75 mm (0.108 in.). Dia. 3 > 6.02 mm (0.2371 in.). Dia. 2 > 33.03 mm (1.3004 in.).
Zone B	Touch-up depth > 0.1 mm (0.004 in.). Crack.
Zone C	Crack. Scratch depth > 0.2 mm (0.008 in.).

Location as specified in Figure 2 to paragraph (g)(1)(ii) of this AD	Maximum damage, which causes replacement (E1, Dia. 2, Dia. 3, and Dia. 4 are shown in Figure 2 to paragraph (g)(1)(ii) of this AD)
Zone D [Dia. 4 = 14 mm +/- 0.1 mm (0.548; 0.555in.)]	Touch-up depth > 0.1 mm (0.004 in.). Crack. E1 < 2.75 mm (0.108 in.).
