**[Docket No. FAA-2025-2546; Project Identifier AD-2025-01060-T]**

#### **Airworthiness Directives; The Boeing Company Airplanes**

**ACTION:** Notice of proposed rulemaking (NPRM).

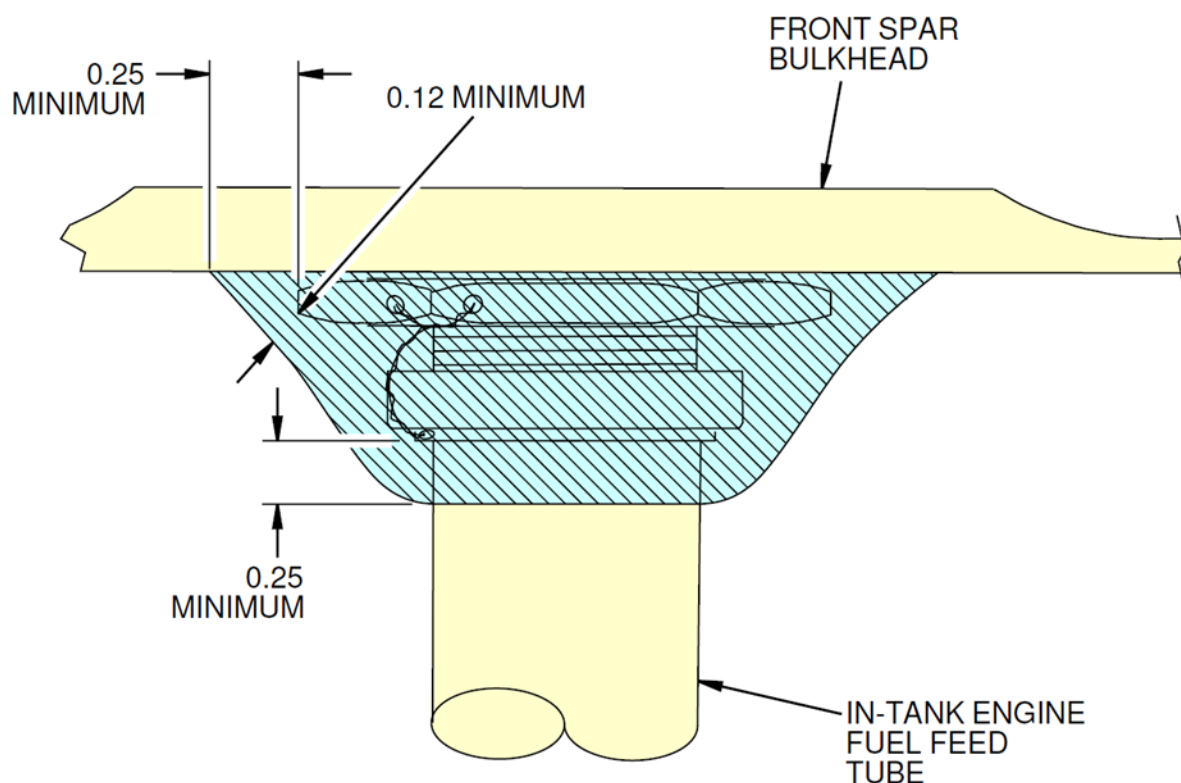
**Figure 2 to paragraph (i) – Fuel Feed Encapsulation**

that location. The bulkhead fitting's encapsulation is designed to isolate any sparks or arcing generated at the bulkhead fitting during a lightning strike because of failed electrical bonds from flammable fuel vapors in the tank. This fitting, including the in-tank coupler connecting the fuel feed tube to the fitting, is the most probable location for sparking when electrical bonding is poor. Therefore, a failed encapsulation significantly increases the risk of a fuel tank explosion following a lightning strike to the engine nacelle on an airplane with poor electrical bonding. Analysis has shown that at least a subset of the encapsulation failures seen on Model 747 airplanes is expected on Model 777 airplanes.

The observed encapsulation failures are frequently associated with inadequate application of the encapsulation sealant. While failures are partly attributable to the design of the fitting and its associated coupler, sealant is frequently applied too thinly, does not cover the entire fitting and coupler, does not extend sufficiently onto the fuel feed tube, or the relevant surfaces are inadequately cleaned prior to application, preventing proper sealant adhesion.

Within 60 days after the effective date of this AD, revise the existing maintenance or inspection program, as applicable, to incorporate the information specified in Figure 1 and Figure 2 to paragraph (i) of this AD.
