[Docket No. FAA-2025-3438; Project Identifier AD-2025-01163-A]

Airworthiness Directives; Twin Commander Aircraft LLC Airplanes

ACTION: Notice of proposed rulemaking (NPRM).

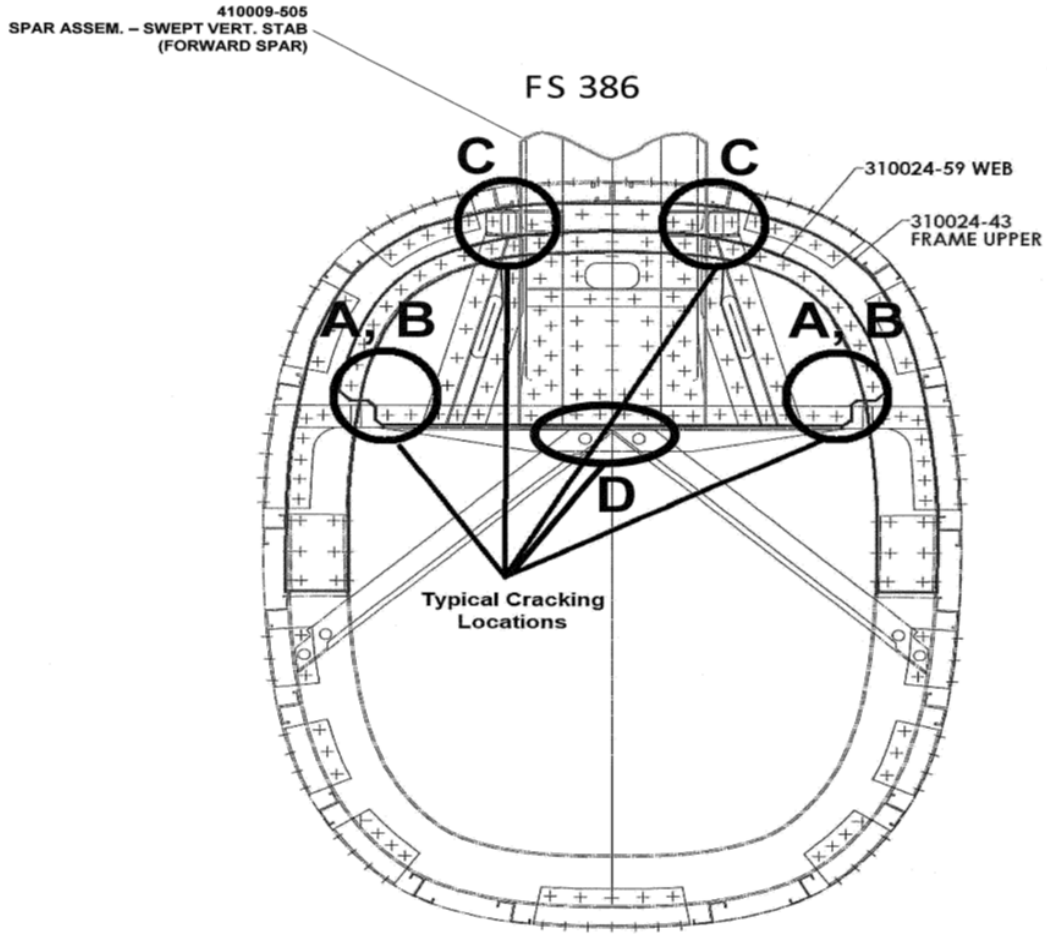
Figure 1 to Appendix 1

(A) Fuselage Station (FS) 386: Frame Web at each corner radius

(B) FS 386: Horizontal Brace Joggles

(C) FS 386: Frame Upper Cable Cutouts

(D) FS 386: Diagonal Braces

(ii) A detailed visual inspection for cracks, elongation, or deformation of the working fasteners at location (D) FS 386 diagonal braces, using at least 10x magnification.

- (A) FS 386: Frame Web at each corner radius
- (B) FS 386: Horizontal Brace Joggles
- (C) FS 386: Frame Upper Cable Cutouts
- (D) FS 386: Elongation of Holes at the Diagonal Braces

(2) If, during the inspections required by paragraph (g)(1)(i), (ii), or (iii) of this AD, any evidence of cracks, corrosion, or loose hardware is found at FS 386, or FS 409, or FS 429 or the vertical stabilizer or cracks, elongation, or deformation are found to the holes of the working fasteners at the diagonal braces of FS 386, before further flight, replace with new parts with zero hours TIS or used parts that have been inspected per paragraphs (g)(1)(i), (ii), and (iii) of this AD and found to be free of cracks corrosion, or loose hardware, or repair using a method approved by the Manager, East Certification Branch, FAA. For a repair method to be approved by the Manager, East Certification Branch, FAA as required by this paragraph, the Manager's approval letter must specifically refer to this AD.

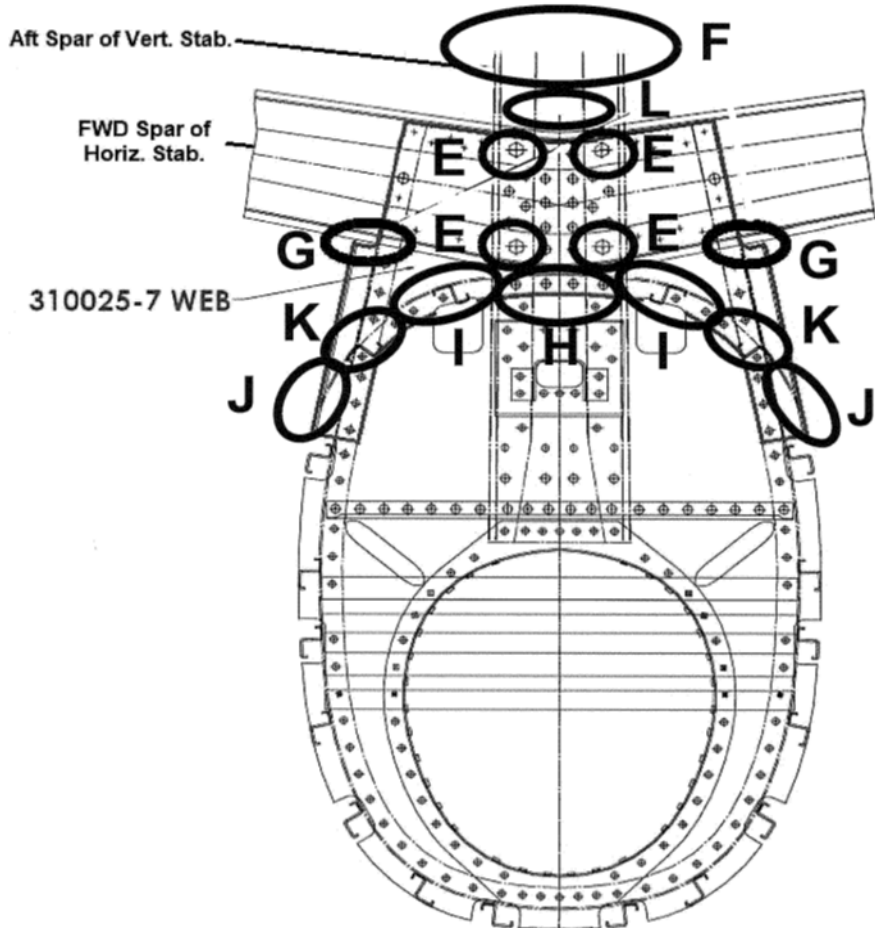
Figure 2 to Appendix 1

- (E) FS 409: Horizontal Stabilizer Front Spar
- (F) FS 409: Vertical Stabilizer Spar Web
- (G) FS 409: Frame Web at each corner fillet radius
- (H) FS 409: Frame Web below Horizontal Stabilizer Spar
- (I) FS 409: Frame Tangs attaching fuselage skin
- (J) FS 409: Exterior Fuselage Skin at cutouts corners
- (K) FS 409: Exterior Fuselage Skin at frame tang attachment
- (L) FS 409: Vertical Stabilizer Spar Web Forward and Aft Clips

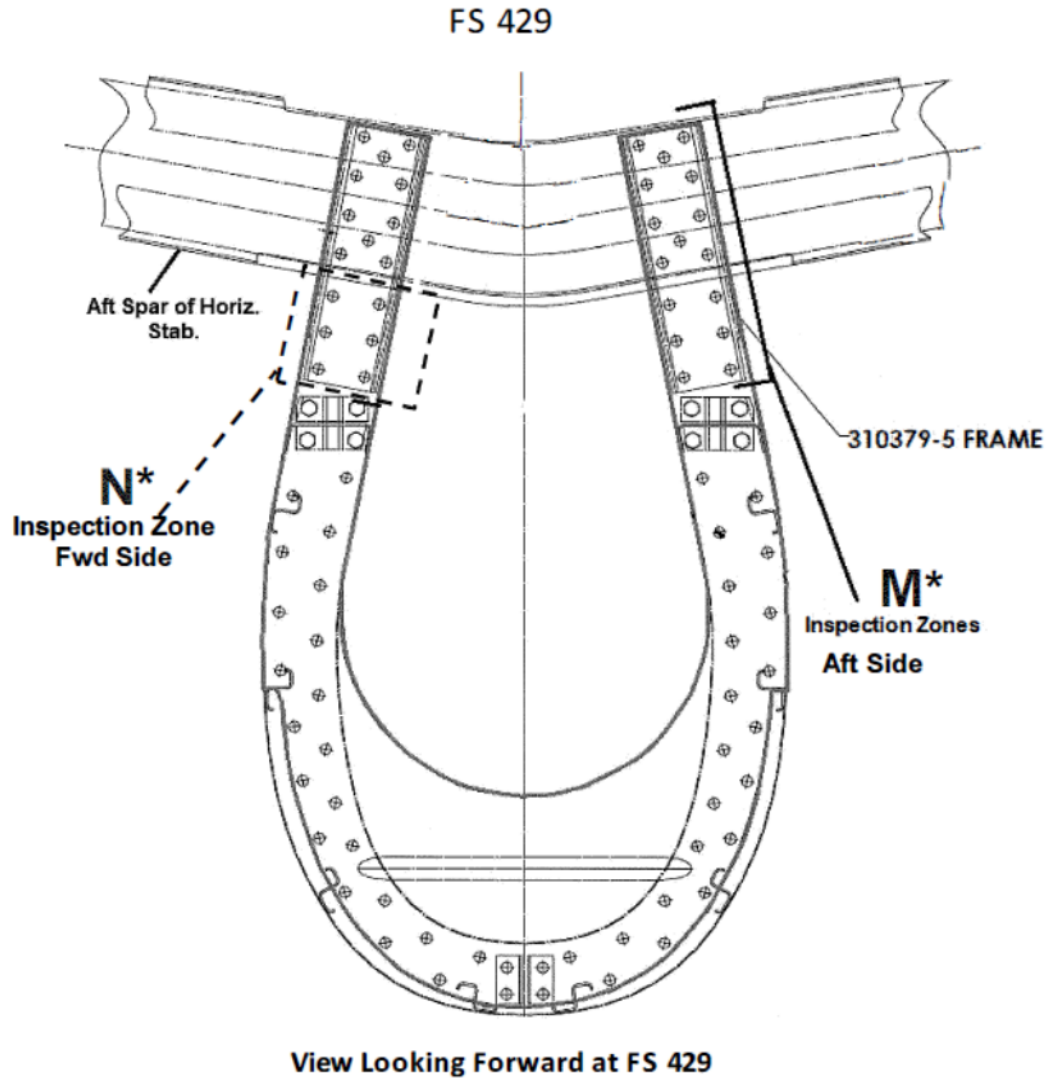
Figure 3 to Appendix 1

(M) FS 429: Aft Frame Channel and Web (* inspection mirrored on opposite side)
(N) FS 429: Forward Channel attached to Frame (* inspection mirrored on opposite side)

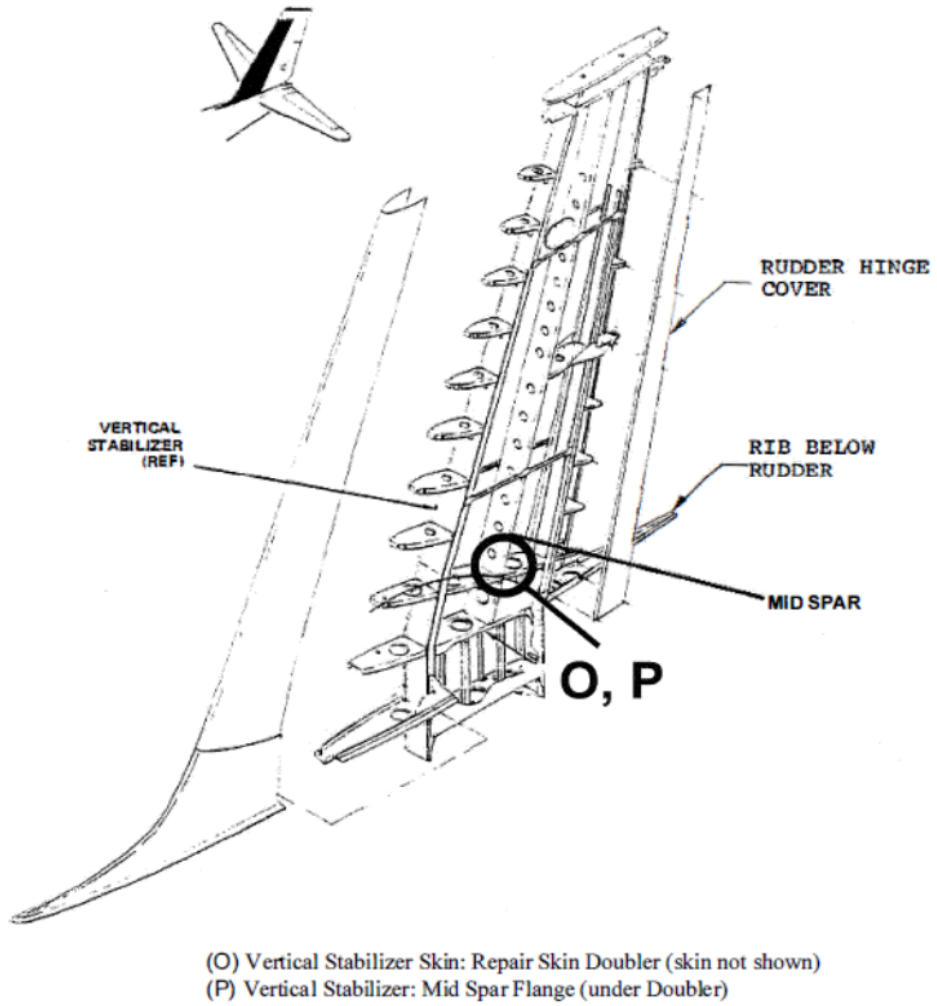
Figure 4 to Appendix 1

(O) Vertical Stabilizer Skin: Repair Skin Doubler

(P) Vertical Stabilizer : Mid Spar Flange
