**[Docket No. FAA-2025-0922; Project Identifier MCAI-2024-00650-R; Amendment
39-23163; AD 2025-20-10]**

Airworthiness Directives; Airbus Helicopters

2025-20-10 Airbus Helicopters: Amendment 39-23163; Docket No. FAA-2025-0922; Project Identifier MCAI-2024-00650-R.

Joint Aircraft System Component (JASC) Code 6422, Tail Rotor System.

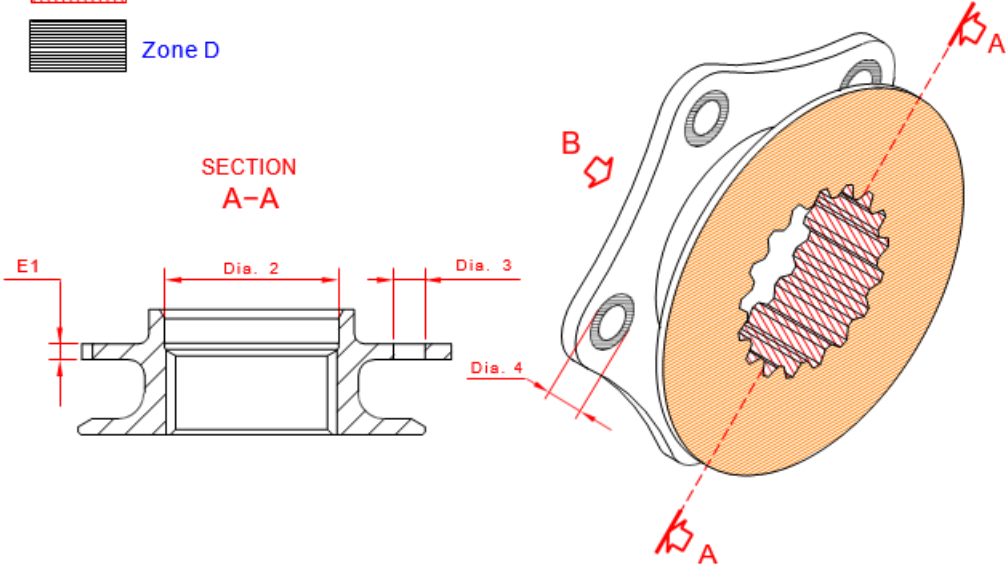
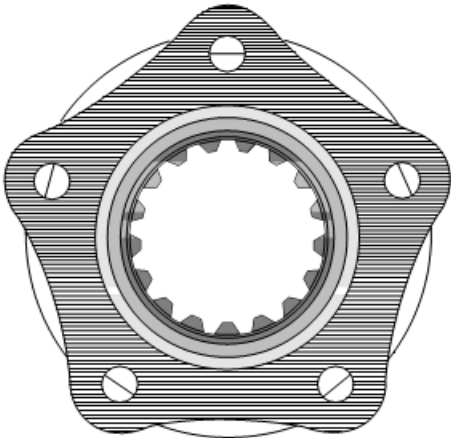
Figure 2 to paragraph (g)(1)(ii) - Inspection Areas of Tail Rotor Splined

(ii) Inspect the TR splined flange for corrosion, impacts, fretting, wear, and a crack in the areas identified in Figure 2 to paragraph (g)(1)(ii) of this AD. If the condition of the part (including corrosion, impacts, fretting, wear, or cracks) exceeds the criteria as

Location as specified in Figure 2 to paragraph (g)(1)(ii) of this AD	Maximum damage, which causes replacement (E1, Dia. 2, Dia. 3, and Dia. 4 are shown in Figure 2 to paragraph (g)(1)(ii) of this AD)
Zone A	Scratch depth > 0.2 mm (0.008 in.). Crack. E1 < 2.75 mm (0.108 in.). Dia. 3 > 6.02 mm (0.2371 in.). Dia. 2 > 33.03 mm (1.3004 in.).
Zone B	Touch-up depth > 0.1 mm (0.004 in.). Crack.
Zone C	Crack. Scratch depth > 0.2 mm (0.008 in.).
Zone D [Dia. 4 = 14 mm +/- 0.1 mm (0.548; 0.555in.)]	Touch-up depth > 0.1 mm (0.004 in.). Crack. E1 < 2.75 mm (0.108 in.).

specified in Figure 1 to paragraph (g)(1)(ii) of this AD, before further flight, remove the splined flange from service and replace with an airworthy part.
