Amendment 39-23280; AD 2026-05-07]

Airworthiness Directives; The Boeing Company Airplanes

ACTION: Final rule.

SUMMARY: The FAA is adopting a new airworthiness directive (AD) for certain The Boeing Company Model 767-200, -300, -300F, and -400ER series airplanes. This AD was prompted by discovery of a crack at one of the forward lower fastener holes following replacement of a cracked underwing longeron (UWL) fitting. This AD requires performing an open hole high frequency eddy current (HFEC) inspection for cracks of the fastener holes common to the UWL fitting, upper drag splice angle, and lower drag splice angle, and applicable on-condition actions. The FAA is issuing this AD to address the unsafe condition on these products.

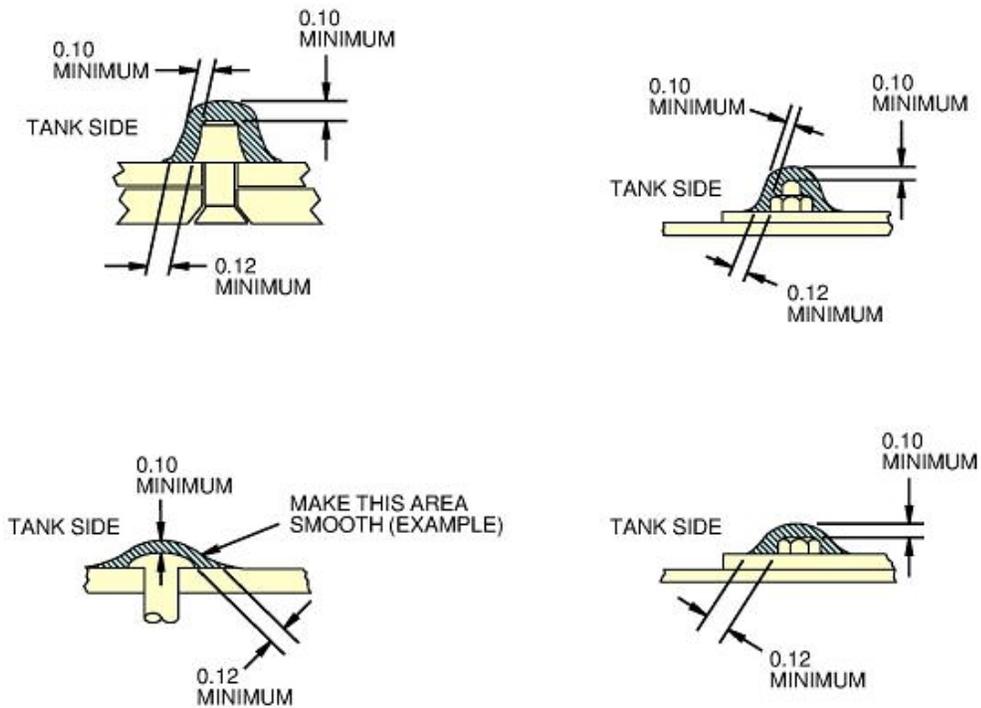
Figure 1 to paragraph (h)(4) – Cap seal minimum thickness (all dimensions in inches)

The FAA agrees that the cap sealing requirement of paragraph (h)(4) of this AD (corresponding to paragraph (h)(3) of the proposed AD) does not apply to fasteners outside the fuel tank. Accordingly, the FAA has revised paragraph (h)(4) of this AD to clarify the requirement applies only to fasteners, fastener heads, and fastener threads and collars inside the fuel tank.

(4) During application of any cap seal to a fastener, fastener head, and fastener threads and collars inside the tank, as required by this AD, the cap seal must be applied with a thickness equal to or greater than the dimensions specified in figure 1 to paragraph (h)(4) of this AD.
