[Docket No. FAA-2026-2712; Project Identifier AD-2025-00931-T]

Airworthiness Directives; The Boeing Company Airplanes

ACTION: Notice of proposed rulemaking (NPRM).

2019-20-07, which applies to all The Boeing Company Model 787-8, 787-9, and 787-10 airplanes. AD 2019-20-07 requires repetitive operational checks of the leading edge (LE) outboard (OB) slats and applicable on-condition actions. AD 2019-20-07 also requires revising the airplane flight manual (AFM) to prohibit flap retraction under icing conditions and revising the existing maintenance or inspection program, as applicable, to incorporate a new operation check. Since the FAA issued AD 2019-20-07, the manufacturer developed further actions to address the unsafe condition. This proposed AD would retain all requirements of AD 2019-20-07 and would require replacing the LE outboard geared rotary actuator (GRA) with a LE outboard lockout actuator (LEOLA) at leading edge OB slat locations and revising the existing maintenance or inspection program, as applicable, to incorporate a new certification maintenance requirement (CMR). This proposed AD would also remove airplanes from the applicability. The FAA is proposing this AD to

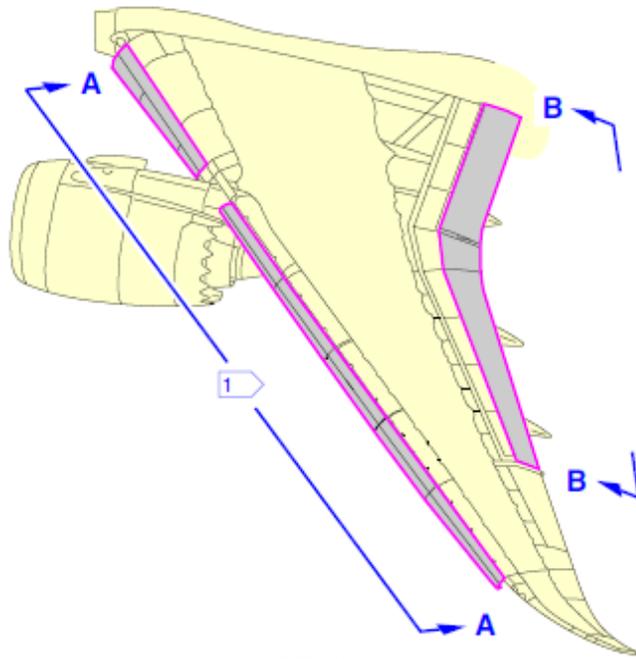
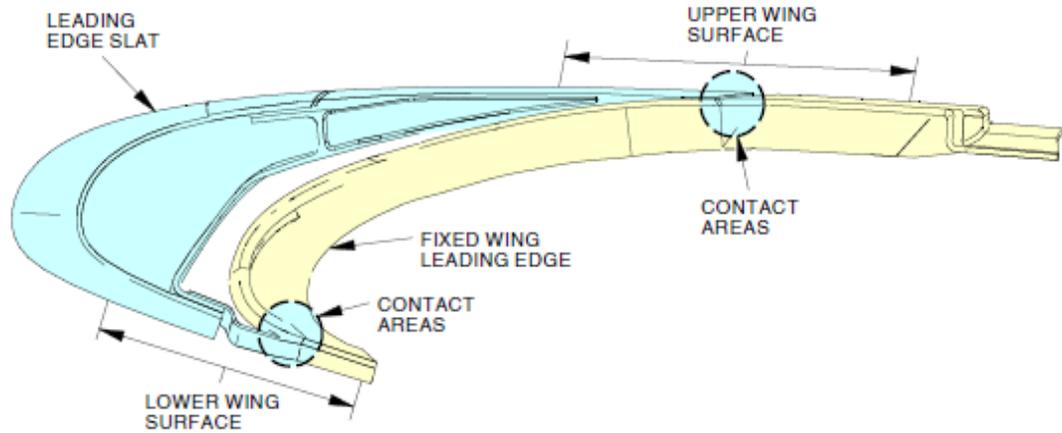
Figure 2 (Sheet 1 of 3) Slat and Flap Inspection

1 INSPECT ENTIRE LENGTH OF LEADING EDGE SLATS
AND FIXED WING LEADING EDGE IN THIS AREA

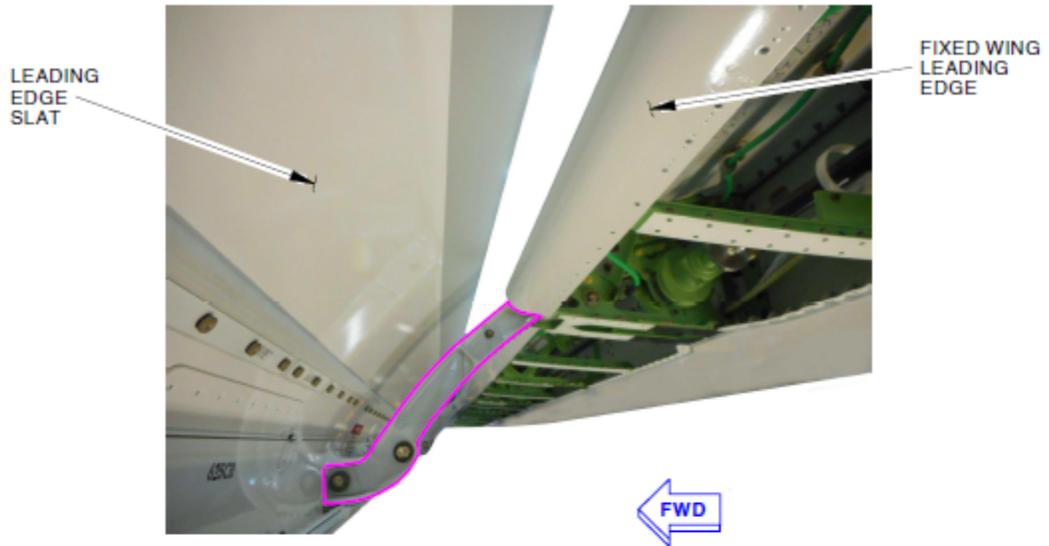
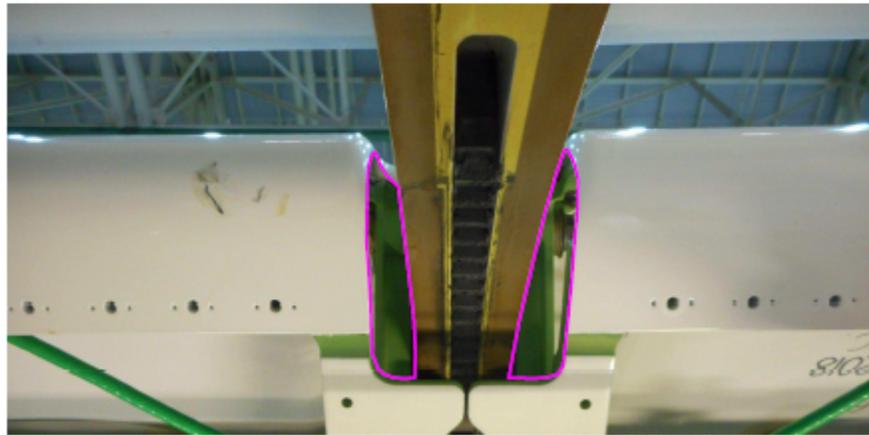
Figure 2 (Sheet 2 of 3) Slat and Flap Inspection

**ACTUATION AREAS
(TYPICAL)
A-A**

**SLAT TRACK CAVITY
(TYPICAL)
(VIEW IN THE AFT DIRECTION)
A-A**
