## **DEPARTMENT OF TRANSPORTATION**

**Amendment 39-23414; AD 2026-15-02]**

#### **Airworthiness Directives; The Boeing Company Airplanes**

**SUMMARY:** The FAA is superseding Airworthiness Directive (AD) 2024-19-14, which applied to certain The Boeing Company Model 777-200, 777-200LR, 777-300ER, and 777F series airplanes. AD 2024-19-14 required repetitive inspections and bond resistance measurement of the bonding jumpers on the first fuel feed tube installed immediately forward of the wing front spar at the left and right main fuel tank penetrations and applicable corrective actions. This AD was prompted by a determination that additional inspections are required to address the unsafe condition. This AD requires repetitive detailed inspections (DETs), repetitive bond resistance measurement, and applicable on-condition actions. This AD also expands the applicability and requires revising the existing maintenance or inspection program, as applicable, to incorporate a certain airworthiness limitation. The FAA is issuing this AD to address the unsafe condition on these products.

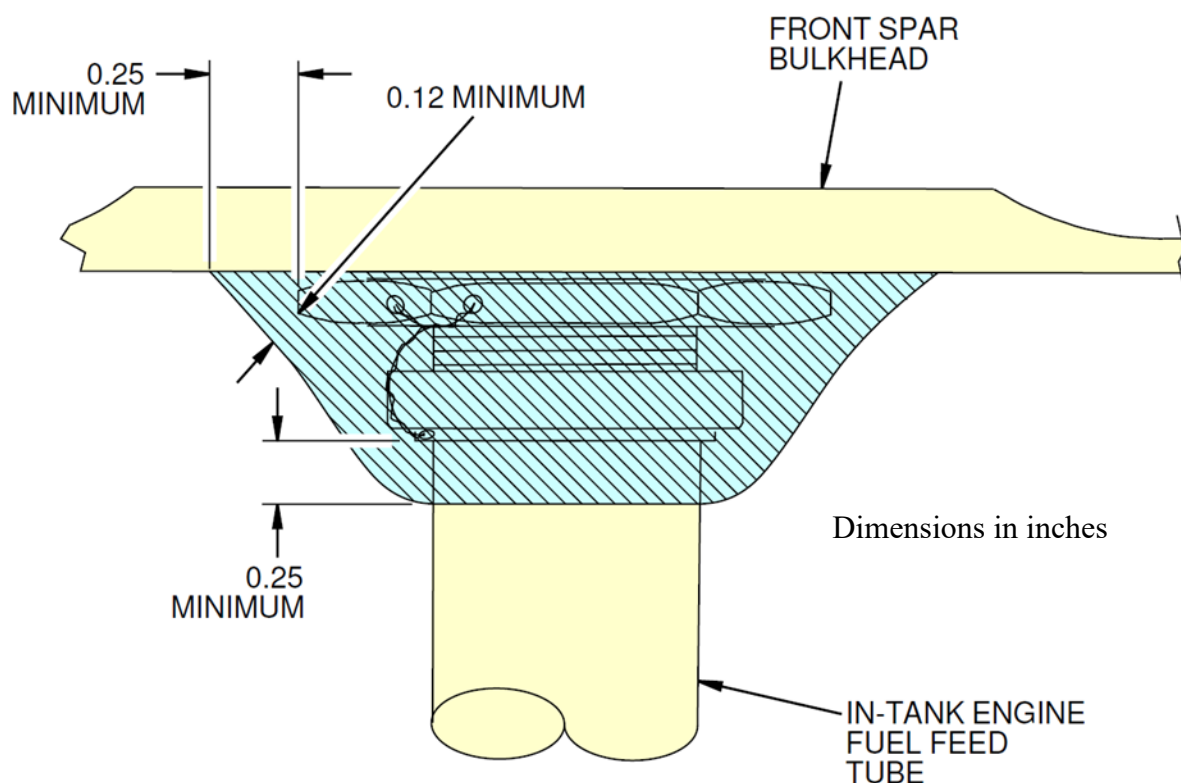
**Figure 2 to paragraph (i) – Fuel Feed Encapsulation**

| AWL<br>NUMBER | TASK | INTERVAL | APPLICABILITY | DESCRIPTION |
|---|---|---|---|---|
| 28-AWL-05 | CDCCL | N/A | ALL | <p>Lightning Protection – Engine Fuel Feed Line Fuel Tank Penetration Bonding to Spar</p> <p>Concern: Potential for arcing or sparking inside the tank at the interface between the bulkhead fitting and the spar during a lightning strike event.</p> <p>The following design features must be verified (refer to Boeing AMM 28-22-15) if the bulkhead fitting or attached tubing is removed and reinstalled or replaced:</p> <ol style="list-style-type: none"> <li>1. A fay sealed fay surface bond is installed between the bulkhead fitting and the front spar inside the tank.</li> <li>2. The electrical bonding resistance across the fay surface between the bulkhead fitting and the front spar inside the tank is 0.0010 ohm (1.0 milliohm) or less.</li> <li>3. Bonding jumpers are installed as follows. <ol style="list-style-type: none"> <li>a. For airplane line number 1-829: <ol style="list-style-type: none"> <li>i. A bonding jumper is installed between the first fuel tube mating with the bulkhead fitting and structure inside the tank. <ol style="list-style-type: none"> <li>1. If the tube-to-structure bonding jumper was removed and reinstalled or replaced, the electrical bonding resistance between the structure and the first fuel tube mating with the bulkhead fitting inside the tank is 0.0100 ohm (10.0 milliohms) or less.</li> </ol> </li> </ol> </li> <li>b. For airplane line numbers 830 and on: <ol style="list-style-type: none"> <li>i. A bonding jumper is installed between the first fuel tube mating with the bulkhead fitting and the second AFT fuel tube inside the tank. <ol style="list-style-type: none"> <li>1. If the tube-to-tube bonding jumper was removed and reinstalled or replaced, the electrical bonding resistance between the first fuel tube mating with the bulkhead fitting and second AFT fuel tube inside the tank is 0.0100 ohm (10.0 milliohms) or less.</li> </ol> </li> </ol> </li> </ol> </li> </ol> |

| | | | | <ul style="list-style-type: none"> <li>ii. A bonding jumper is installed between the second AFT fuel tube and structure inside the tank. <ul style="list-style-type: none"> <li>1. If the tube-to-structure bonding jumper was removed and reinstalled or replaced, the electrical bonding resistance between the structure and the second AFT fuel tube inside the tank is 0.0100 ohm (10.0 milliohms) or less.</li> </ul> </li> <li>4. A full-bodied fillet seal is installed that encapsulates the bulkhead fitting to the front spar and the coupling nut inside the tank. (Refer to Boeing AMM 28-22-15/201 Temporary Revision published between September 16, 2025, and September 17, 2025; Boeing AMM 28-22-15/201 published on or after January 5, 2026.) <ul style="list-style-type: none"> <li>a. The sealant is smooth and the sealant meets the required dimensions as specified in the accompanying figure. <ul style="list-style-type: none"> <li>i. Sealant is considered sufficiently thick when the outline of the coupling or fitting hardware is not visible under the sealant.</li> </ul> </li> <li>b. Each sealant interface passes an adhesion test using a Frixion eraser. <ul style="list-style-type: none"> <li>i. Peeling of the brushcoat is not considered a failure if the peeling stops before the Class B seal.</li> </ul> </li> </ul> </li> </ul> |
