[Docket No. FAA-2026-2712; Project Identifier AD-2025-00931-T]

Airworthiness Directives; The Boeing Company Airplanes

ACTION: Notice of proposed rulemaking (NPRM).

2019-20-07, which applies to all The Boeing Company Model 787-8, 787-9, and 787-10 airplanes. AD 2019-20-07 requires repetitive operational checks of the leading edge (LE) outboard (OB) slats and applicable on-condition actions. AD 2019-20-07 also requires revising the airplane flight manual (AFM) to prohibit flap retraction under icing conditions and revising the existing maintenance or inspection program, as applicable, to incorporate a new operation check. Since the FAA issued AD 2019-20-07, the manufacturer developed further actions to address the unsafe condition. This proposed AD would retain all requirements of AD 2019-20-07 and would require replacing the LE outboard geared rotary actuator (GRA) with a LE outboard lockout actuator (LEOLA) at leading edge OB slat locations and revising the existing maintenance or inspection program, as applicable, to incorporate a new certification maintenance requirement (CMR). This proposed AD would also remove airplanes from the applicability. The FAA is proposing this AD to

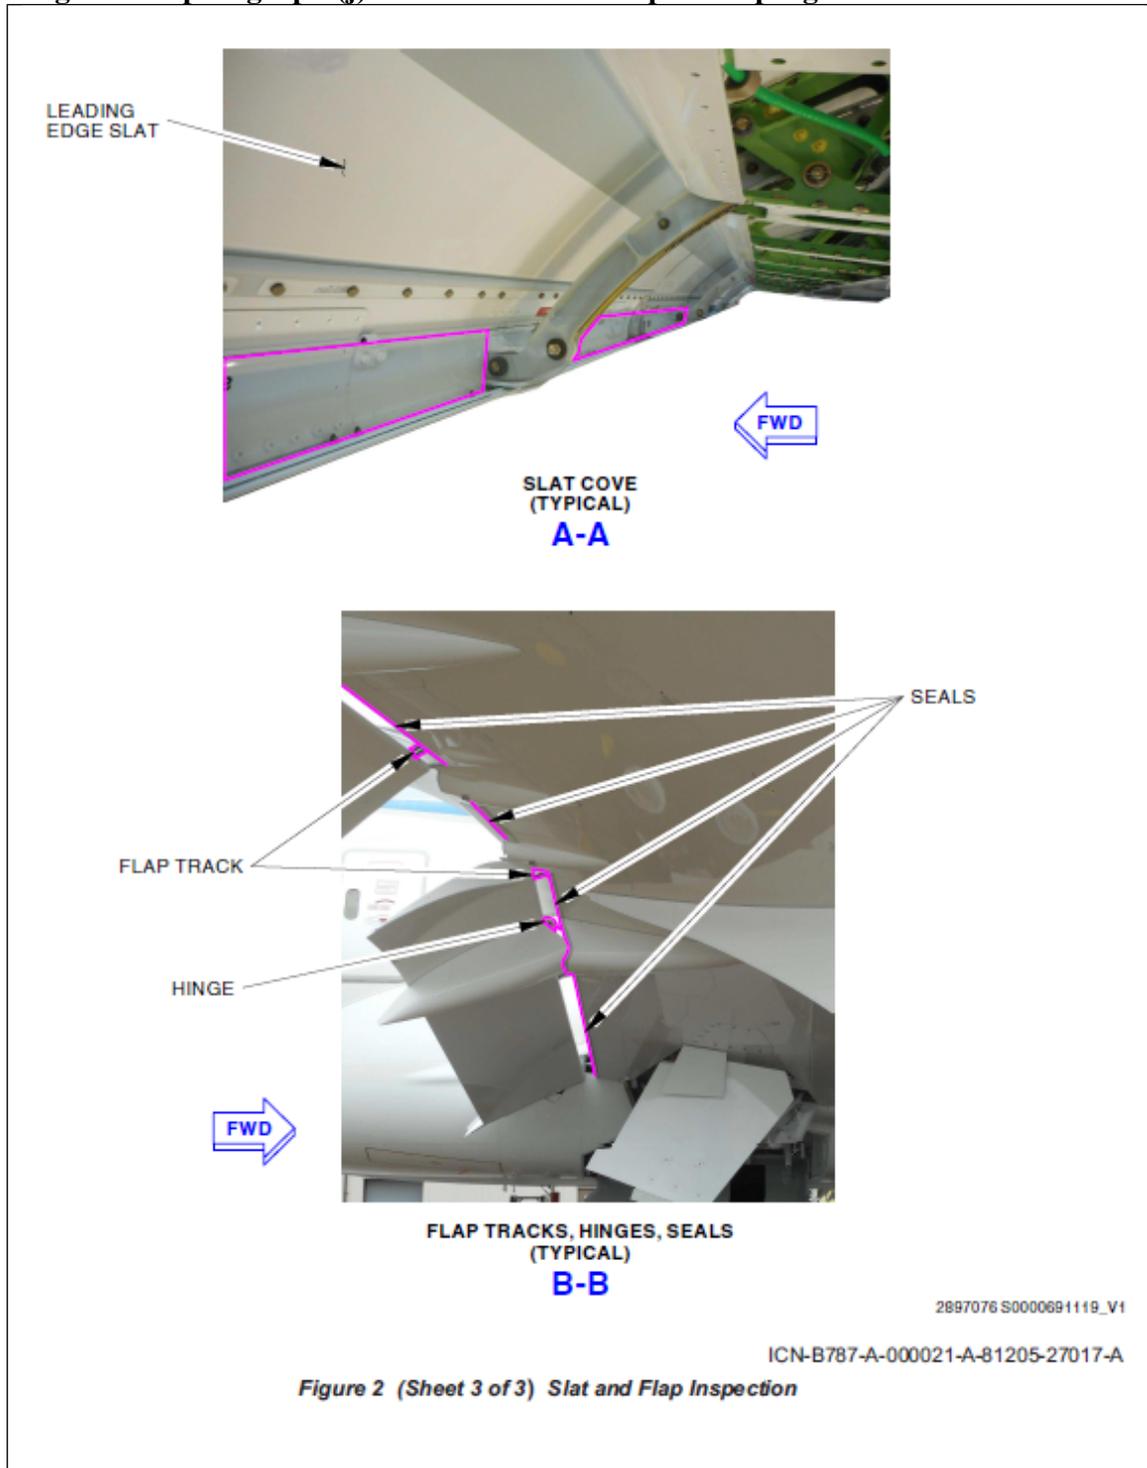
Figure 2 to paragraph (j): Maintenance or inspection program revision continued

After any landing in icing conditions, do this inspection with the slats/flaps (flaps 25 detent) fully extended (Figure 2):

(c) Confirm a contaminant-free condition in these areas immediately prior to retraction of the slats/flaps surfaces.

This paragraph restates the requirements of paragraph (j) of AD 2019-20-07, with no changes. Within 60 days after October 11, 2019 (the effective date of AD 2019-20-07), revise the existing maintenance or inspection program, as applicable, to incorporate the information specified in figure 2 to paragraph (j) of this AD. This may be done by inserting a copy of figure 2 to paragraph (j) of this AD into the existing maintenance or inspection program.
